Subject: Revised Ford Motor Company (Ford) Defect Information Report Regarding
Recall No. 09S09

SAFETY RECALL 09S09 AFFECTED VEHICLES

49 CFR Part 573 -- DEFECT INFORMATION REPORT
FORD RECALL 09S09

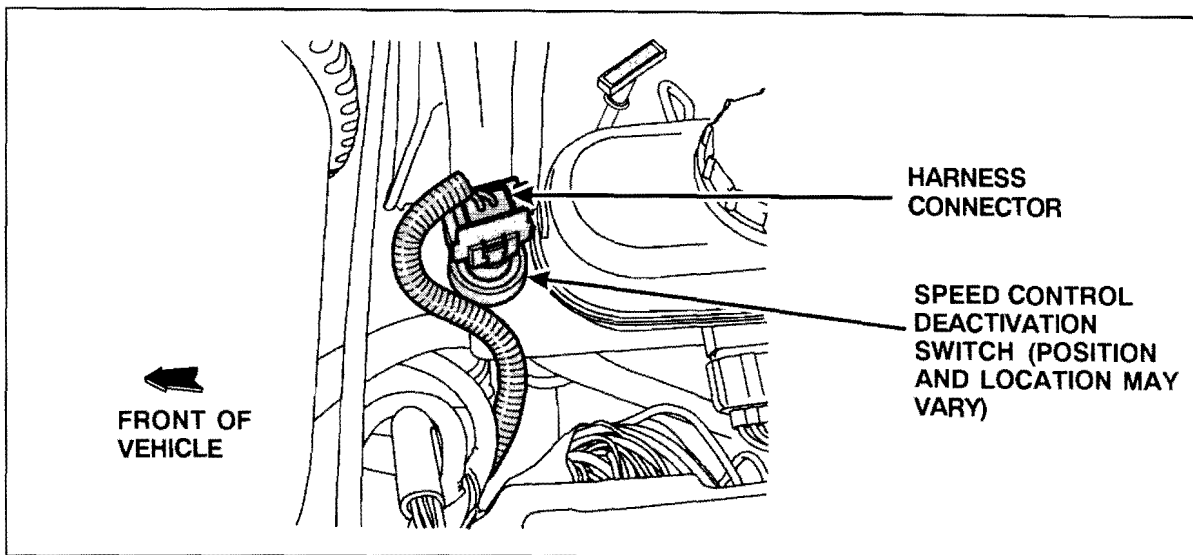
FIGURE 2

2. Inspect the harness connector for the presence of brake fluid.
 - If there is **no** evidence of brake fluid on the connector, install Universal Fused Jumper Harness (UFJH). See page 6.
 - If there **is** evidence of brake fluid on the connector, replace SCDS. See page 7.

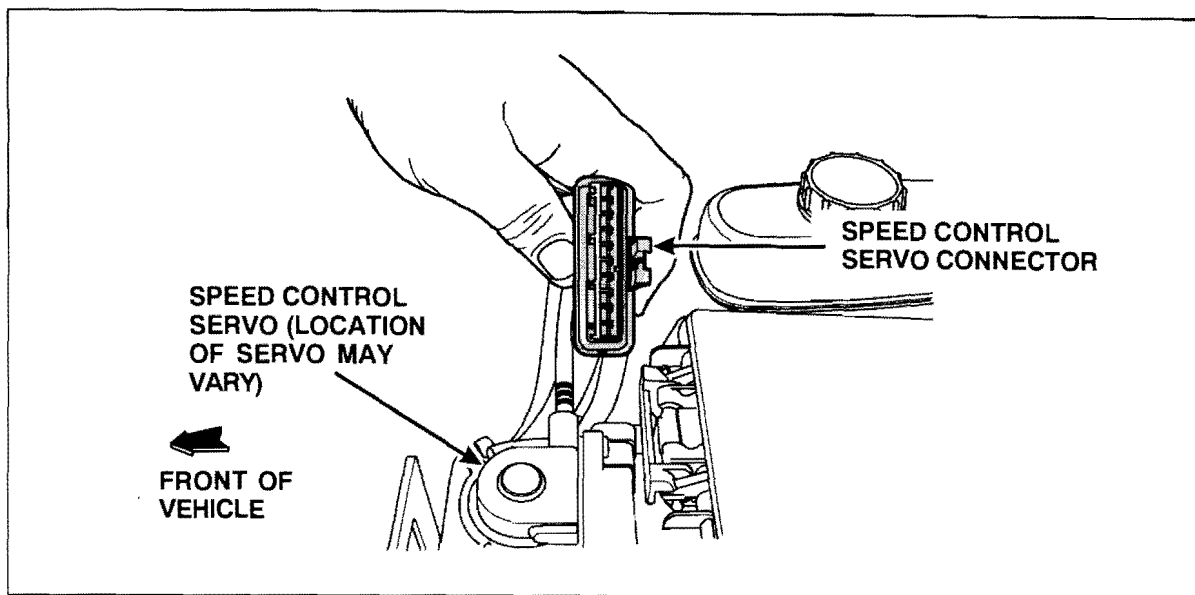
FIGURE 6

1. Disconnect the speed control servo and inspect the vehicle harness connector for heat damage (See Figure 6).
 - If no heat damage is found at the speed control servo connector (even if there is presence of brake fluid in the connector), proceed to step 2 for further instructions.
 - If heat damage is found, proceed as follows:
 - 1999-2003 Windstar, complete ABS inspection on page 11 before calling the Special Service Support Center for further instructions.
 - All other vehicles, call the Special Service Support Center for further instructions.

2. With the speed control servo disconnected, use shop air to blow out any trace of brake fluid from the speed control servo harness electrical connector and the servo module. **Do not use any type of solvent to clean the connectors.**
3. Apply a 5 mm (3/16 in) high bead of **Motorcraft Electrical Grease II (XG-15-A)** across the entire width and length of the servo vehicle harness connector (See Figure 7).

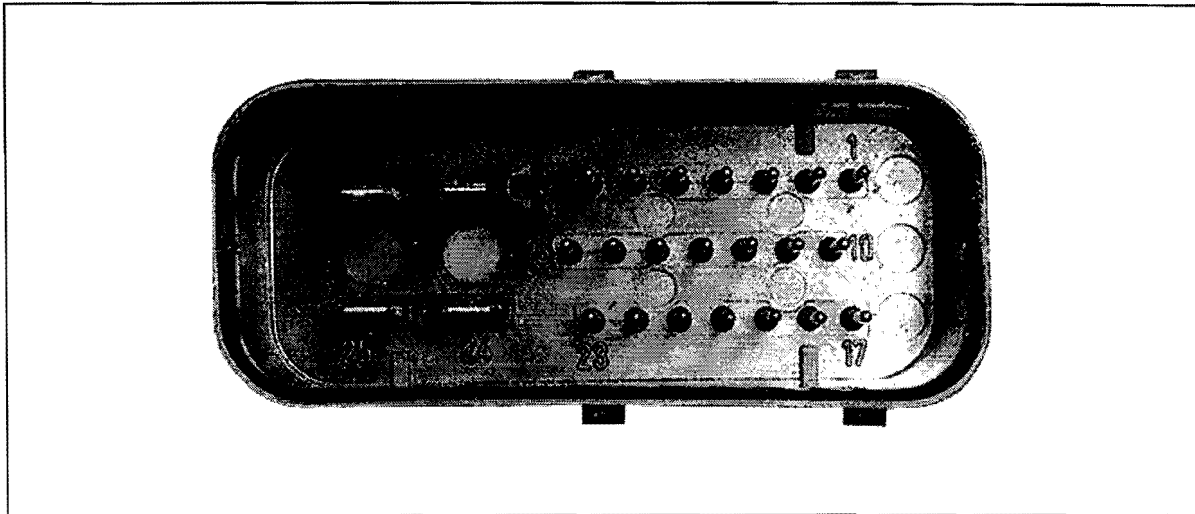
FIGURE 8

1. Lift vehicle and remove ABS cover.
2. Disconnect ABS module. Inspect the ABS harness and module connectors for the presence of brake fluid.
3. If brake fluid is present, use shop air to blow out any trace of brake fluid from the harness connector and module.
4. Inspect the ABS harness and module connectors for corrosion and/or heat damage (See Figure 8).

5. If evidence of corrosion and/or heat damage is found in either the ABS harness or module connector, call the Special Service Support Center for further instructions.
6. If there is no evidence of corrosion and/or heat damage, reconnect the ABS harness to the ABS module.
7. **Is the speed control servo heat damaged?**
 - If the speed control servo is heat damaged, call the Special Service Support Center for further instructions.
 - If the speed control servo is **not** heat damaged, no further action is required, release the vehicle.
