# Toyota Sudden Unintended Acceleration

February 5, 2010

**Safety Research & Strategies, Inc.**  
340 Anawan Street / Ste. 200  
Rehoboth, MA 02769  
Ph. 508-252-2333, Fax 508-252-3137  
[www.safetyresearch.net](http://www.safetyresearch.net)

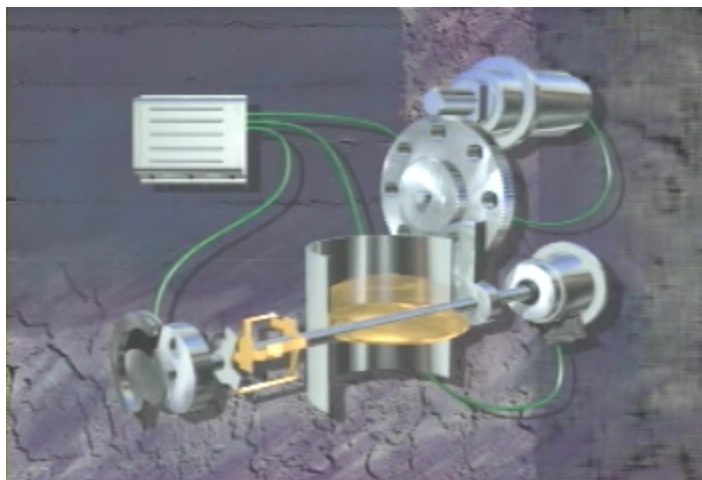
**Figure X: ETCSi with Cable Controlled Accelerator Position Sensor  
(Source: Toyota Motor Sales, Inc.)**

In this design Toyota included a mechanical fail-safe mode in the event of a failure in the ETCS-i. Should the ETCS-i malfunction; the magnetic clutch in the control motor will disengage allowing the accelerator cable to magnetically control the throttle.

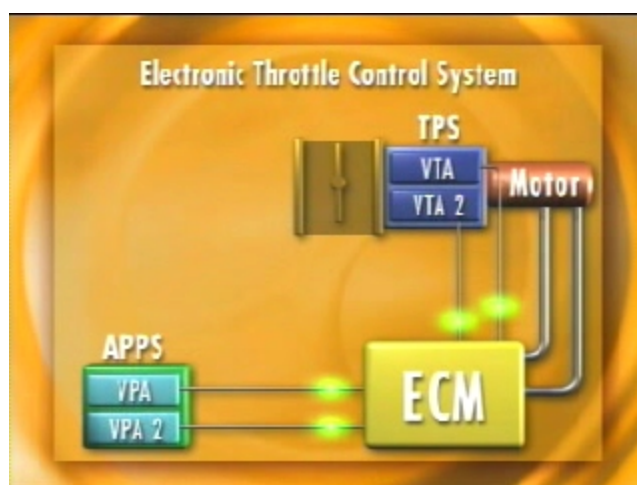
In 2002 Toyota adopted an ETCS-i system that no longer included the mechanical failsafe.<sup>100</sup> This design was used on vehicles like the Camry. The accelerator throttle cable was replaced by an Accelerator Pedal Position Sensor (APPS).<sup>101</sup> The throttle is controlled by information sent by the APPS to the Throttle Position Sensor (TPS). Each of these sensors includes both main and sub-sensor circuits. Based on the voltage signals from these sensors, the ECM controls throttle operation and activates fail safe modes if needed.

**Figure 1: ETCSi without Accelerator Throttle Cable (Linkless)  
(Source: Toyota Motor Sales, Inc.)**

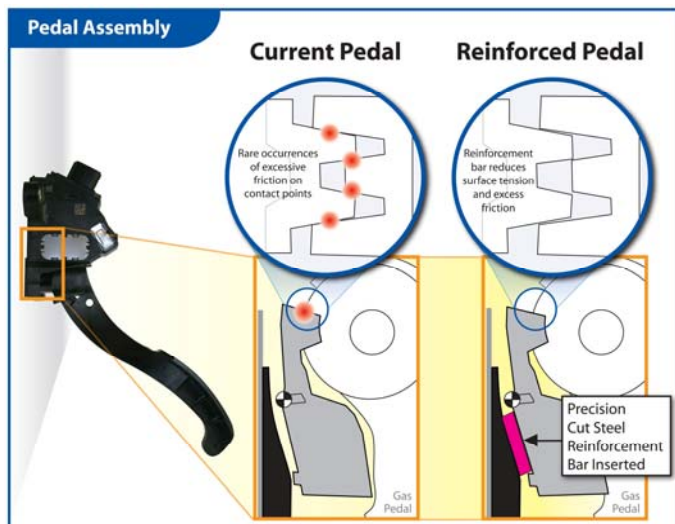
But, in October of 2009, the company received new reports, this time in the U.S. and Canadian markets, of sticking accelerator pedals using the same material friction lever as in the European models.<sup>134</sup>

In January, Toyota announced that it had developed a remedy “that involves reinforcing the pedal assembly in a manner that eliminates the excess friction that has caused the pedals to stick in rare instances.”<sup>135</sup> The subsequent recall included vehicles with friction levers made of both PPS, and PA46, the material first associated with rough operation or slow to return symptoms.<sup>136</sup>

***Toyota sticky pedal remedy: A steel reinforcement bar eliminates the excess friction that can cause the pedal to stick (Source: Toyota Motor Sales)***
