TO: Dill Customers

May 2, 2008

There have been recent reports of a concern with certain rubber snap-in valve stems manufactured under the Dill-ACP brand name and distributed by Dill Air Controls Products, LLC. As a result of recent reports and our investigation, we are advising of this concern affecting TR 413, TR 413 chrome, TR 414, and TR 418 Dill ACP valve stems.

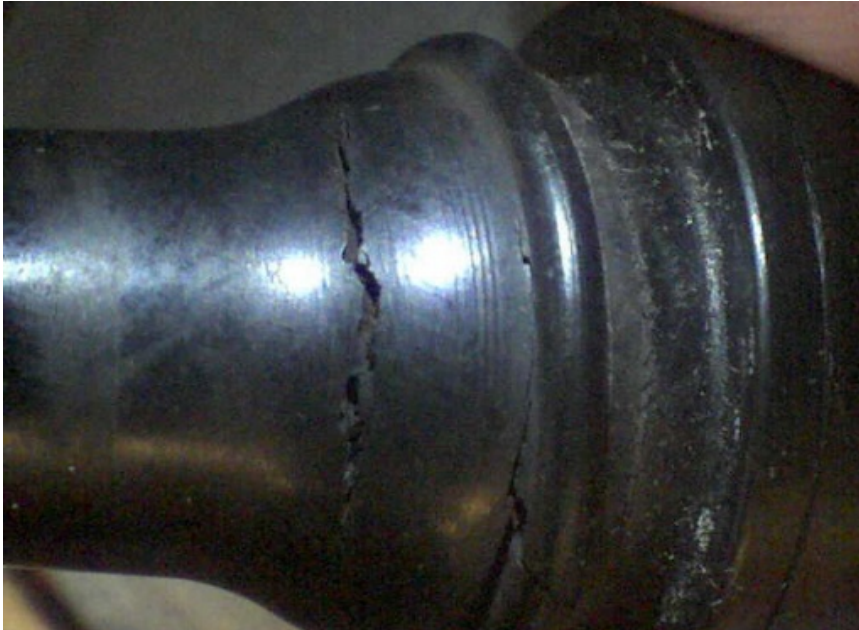
We have received a number of parts showing surface cracks on the outside of the rubber near the rim hole. Our initial investigation based on this anecdotal evidence has centered on ozone exposure. When the rubber is exposed to high levels of ozone as it is being stressed, surface cracks can appear. High speeds and an unsupportive rim profile allow the rubber valve to flex at a greater angle and may cause these cracks to propagate, leading to a slow leak of air.

2. Out of an abundance of caution, we are recommending that when customers return to your stores for regular service, you inspect the valves stems on vehicles who received valve stems during the period from September 2006 – June 2007. This can be done by flexing the valve in a clockwise direction around the rim and looking for cracks above the indicator ring of the valve, for example:

Those valve stems that contain visible surface cracks should be removed and replaced with a new valve stem. This affects the following stems:

- T-13-WZ (TR-413 “Dill ACP” marked on button)
- T-13-WZS (TR-413 “Dill ACP” marked on button with chrome sleeve & chrome cap)
- T-14-WZ (TR-414 “Dill ACP” marked on button)
- T-18-WZ (TR-418 “Dill ACP” marked on button)
