**National Highway
Traffic Safety
Administration**

Subject: **ACTION:** Submittal Roof Crush Analysis Using
1997-2001 NASS Case Review Report, by the
Department of Applied Research, to Docket No.
NHTSA-1999-5572 - 95

Roof Crush Analysis Using 1997-2001 NASS Case Review

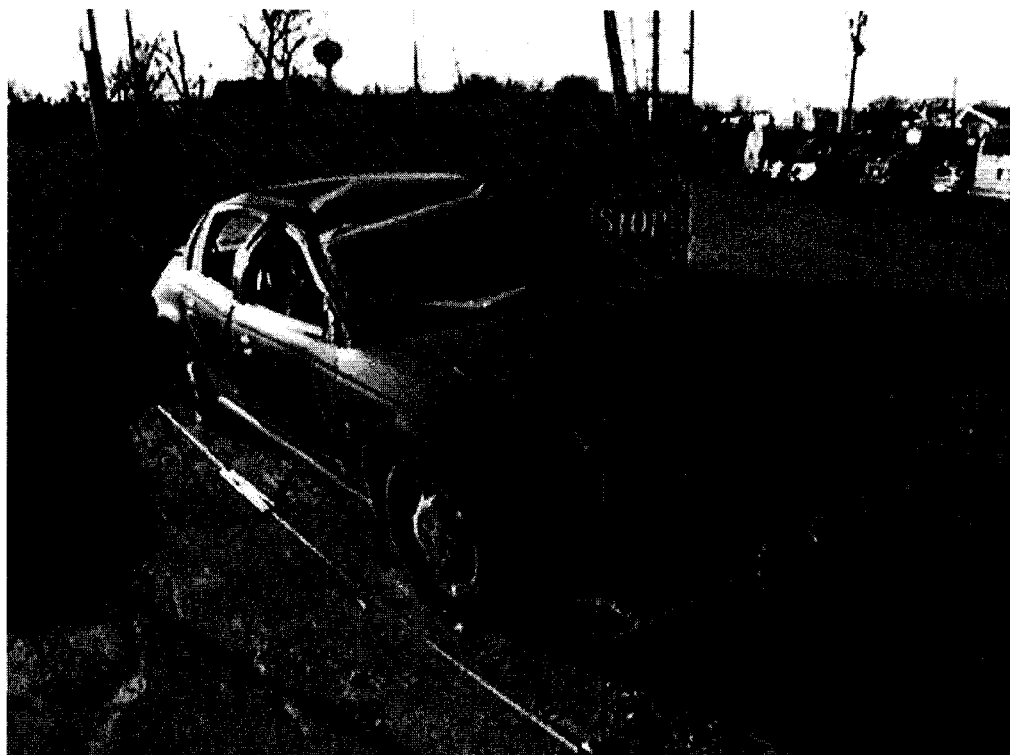
Damage to the hood and roof structure occurred after the vehicle left the roadway and began to roll. The roof was creased laterally across its front and mid sections. The passenger side A and B-pillars were bent. The passenger side A-pillar bent longitudinally at both ends where it connects to the vehicle body and roof. Figure 1 shows a post-crash photo of the A-pillar damage, where it can be seen that the pillar remains almost straight. Figure 2 shows another post-crash photo highlighting the damage to the B-pillar and roof structure. In the photo, the B-pillar is shown experiencing bending near the middle, whereas the A-pillar bent at the ends. The roof bent laterally just behind the A-pillar and B-pillar intersections. The windshield cracked but remained intact and could provide some support to the roof structure.

Figure 1. 1998-72-150, Longitudinal A-pillar Bending (Side View)

Figure 2. 1998-72-150, Longitudinal A-pillar Bending (Oblique View)

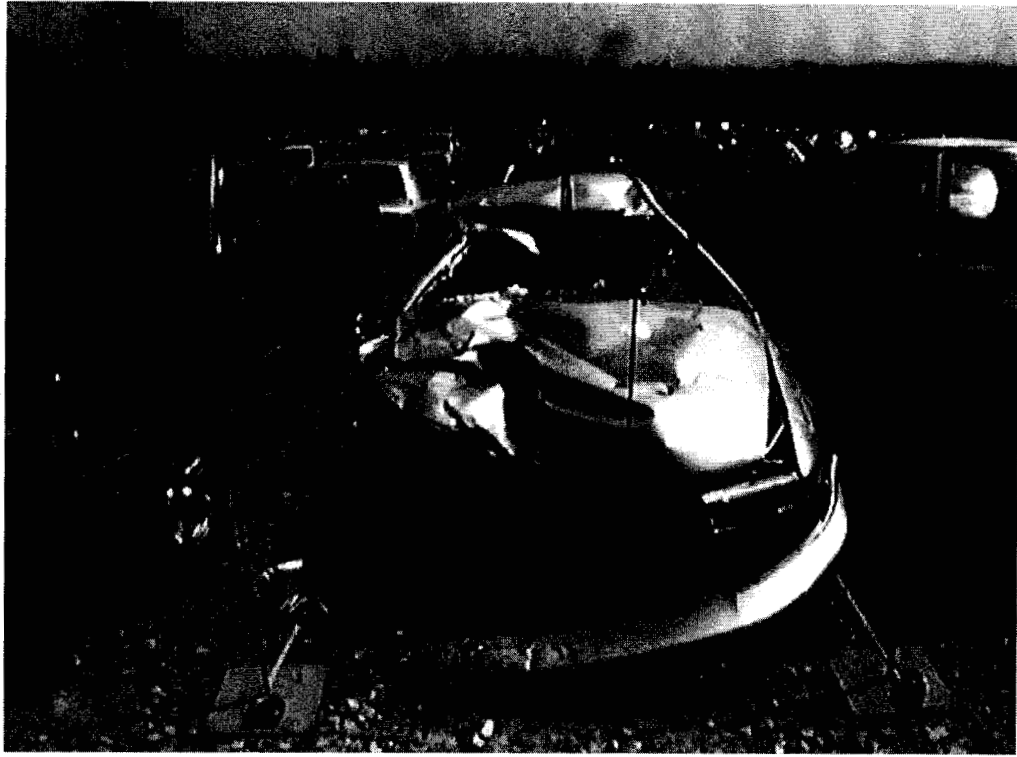
The left side of the vehicle contacted the ground, with damage to the front and mid portion of the roof. Both A-pillars bent inwardly at compound angles but remained fairly straight. The B-pillars remained mostly undamaged. The windshield was holed.

Figure 3. 1999-048-024, Compound A-pillar Bending (Front View)

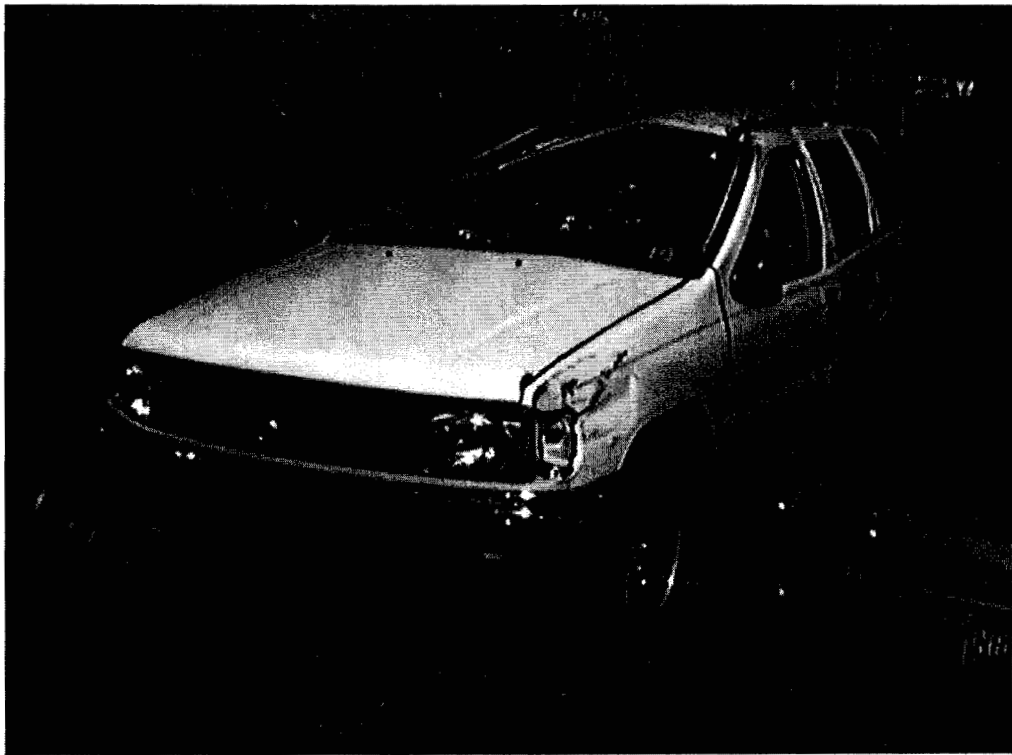
The right side of the vehicle contacted the ground with damage to the A and B-pillars, the roof and roof rail. The A and B-pillar both bent laterally and remained fairly straight. The roof side rail was severely distorted. The roof bent downwards at approximately $\frac{3}{4}$ of the vehicle width. The deformed portion of the roof was planar, deforming at a lateral angle to the undamaged portion of the roof. The damage to the roof extended from the front to the rear of the vehicle.

Figure 4. 1999-4-14, Lateral A-pillar Bending (Front View)

Figure 5. 1999-4-14, Lateral A-pillar Bending (Oblique View)

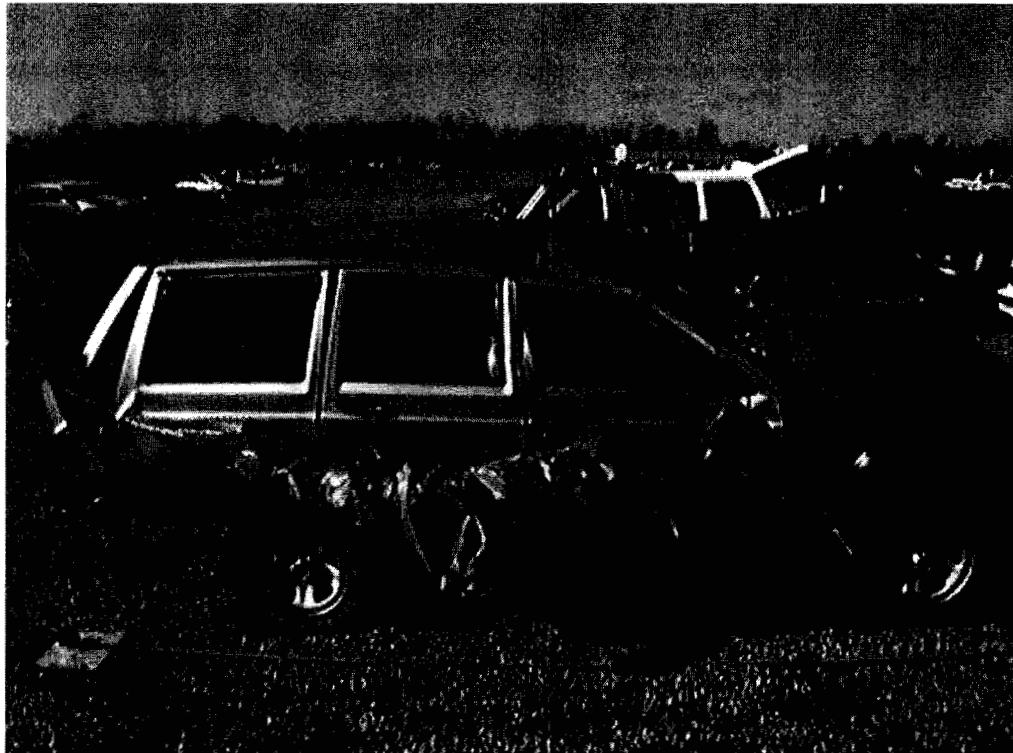
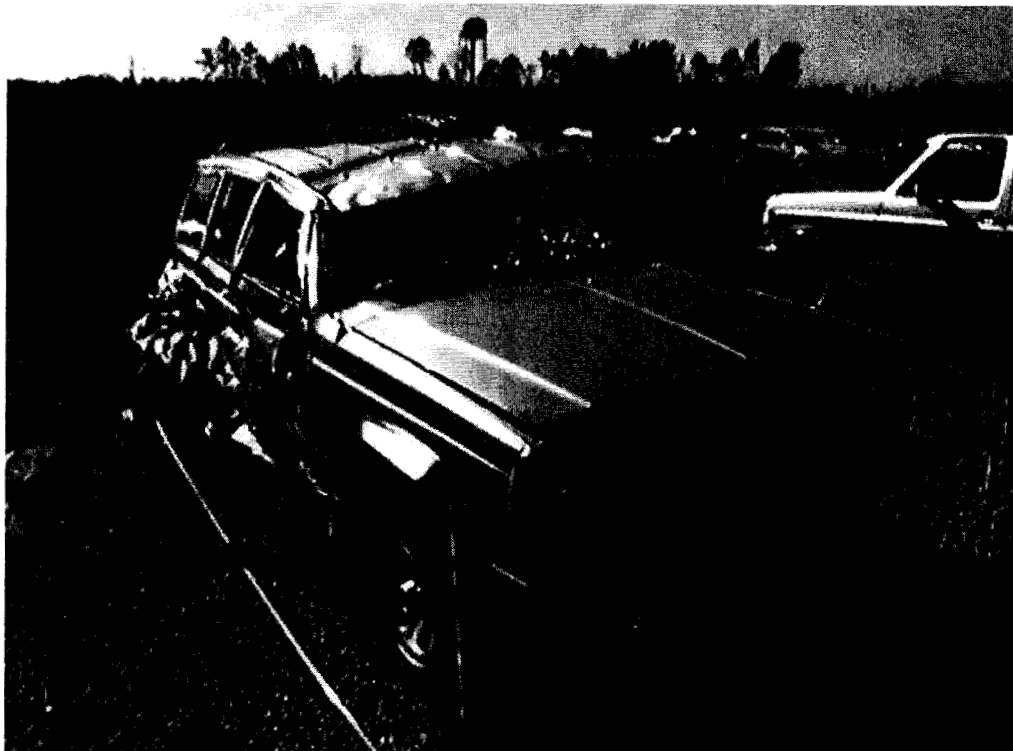
The case vehicle rolled at an angle (caused by lateral and longitudinal sliding) damaging the top of the front passenger side door, A-pillar and roof structure. The roof bent at a compound angle (both laterally and longitudinally). It remained planar sloping downward toward its intersection with the A-pillar. The A-pillar, side roof rail and front header remained fairly straight with the A-pillar bending longitudinally. The B-pillar was undamaged although the side door window frame closest to the B-pillar received minor damage.

Figure 6. 1998-043-303, Combination A-pillar Bending (Side View)

Figure 7. 1998-043-303, Combination A-pillar Bending (Front View)

Figure 8. 1998-043-303, Combination A-pillar Bending (Oblique View)

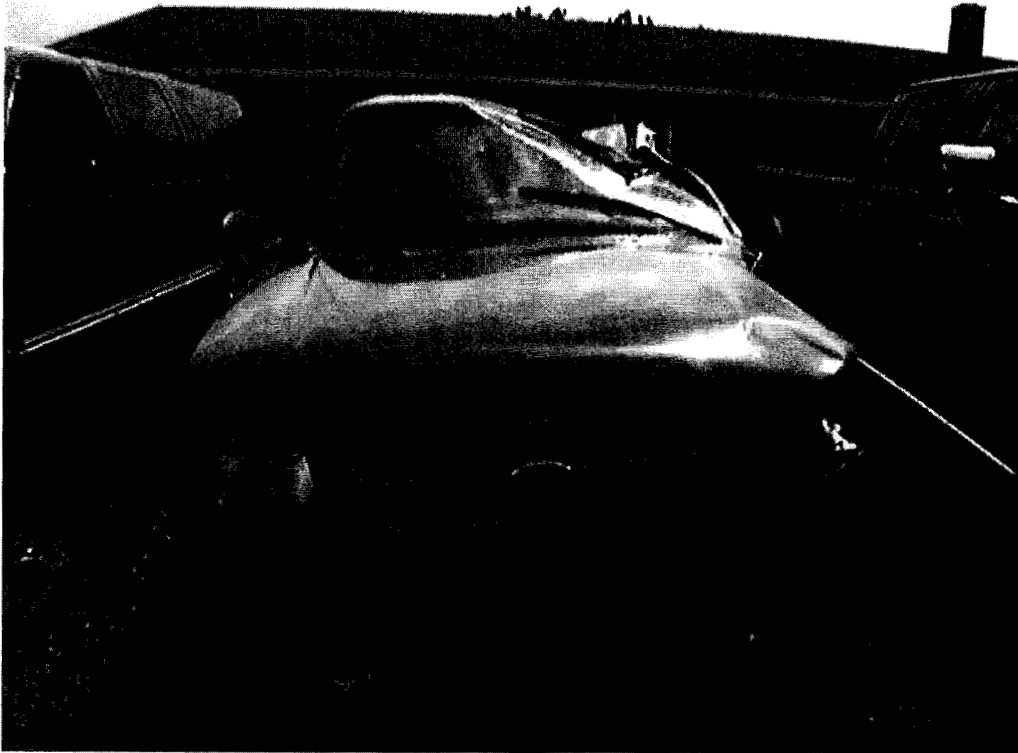
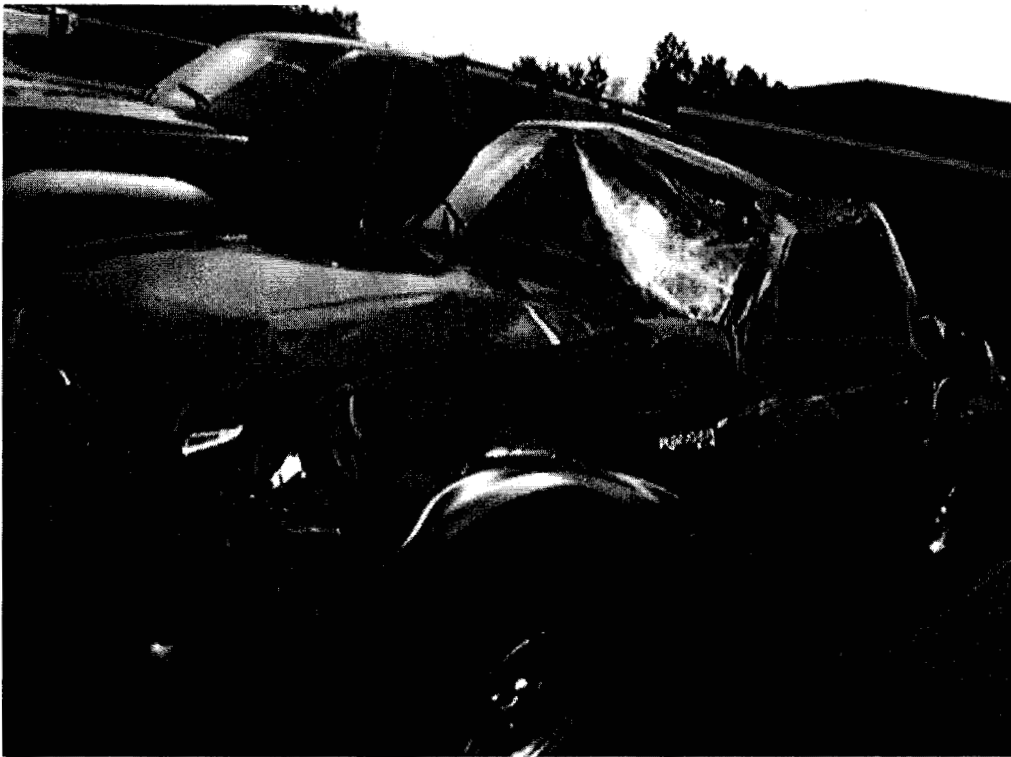
The vehicle exited the roadway from the right and began to rotate clockwise. Ground contact to the A-pillar caused the structure to bend at a compound angle. The A-pillar deformed slightly but remained relatively straight. The roof was damaged with multiple bends; there were no planar areas of damage on the roof (uncommon for composite bending at the A-pillar). The roof rail was also damaged but still remained relatively straight. The windshield was cracked but remained intact.

Figure 9. 1999-11-88, Combination A-pillar Bending (Front View)

Figure 10. 1999-11-88, Combination A-pillar Bending (Oblique View)

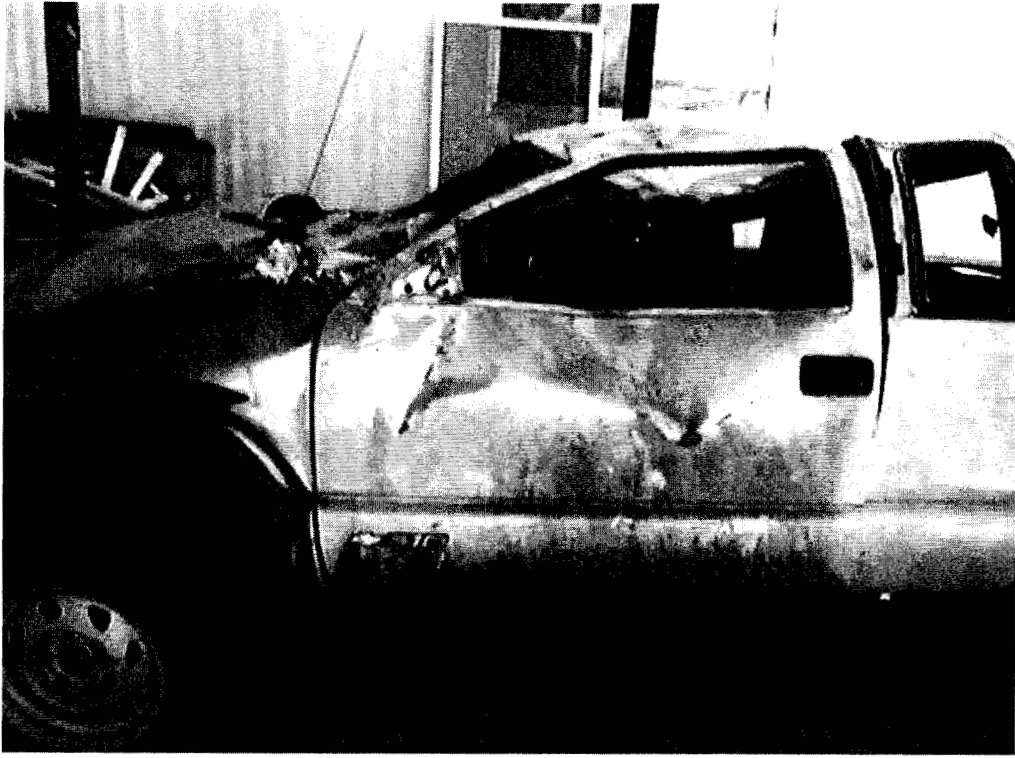
The vehicle initiated its rollover from the passenger side of the vehicle (the right side). The rollover caused damage to the right side quarter panels (front and rear), A-pillar, roof rail, side rail and front header. The quarter panels were dented severely. The right A-pillar was bent at a longitudinal angle. The roof experienced multiple bends. The front windshield was missing.

Figure 13. 1999-078-034, A-pillar Bending along its length (Driver Side View)

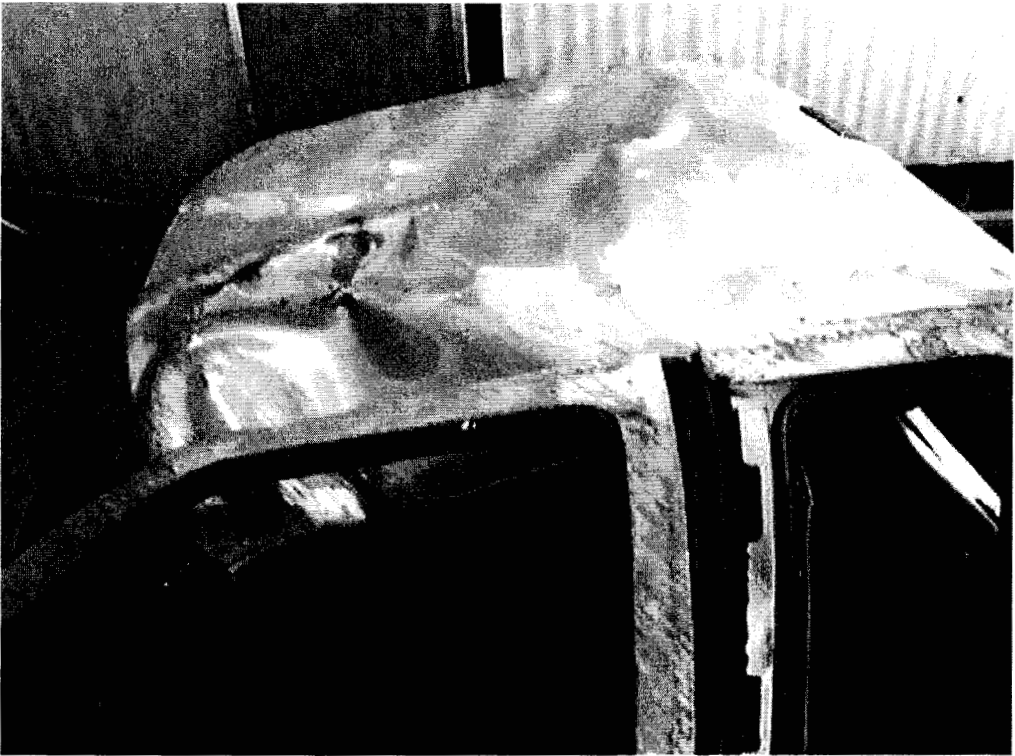
Figure 14. 1999-078-034, Roof Damage (Top View)

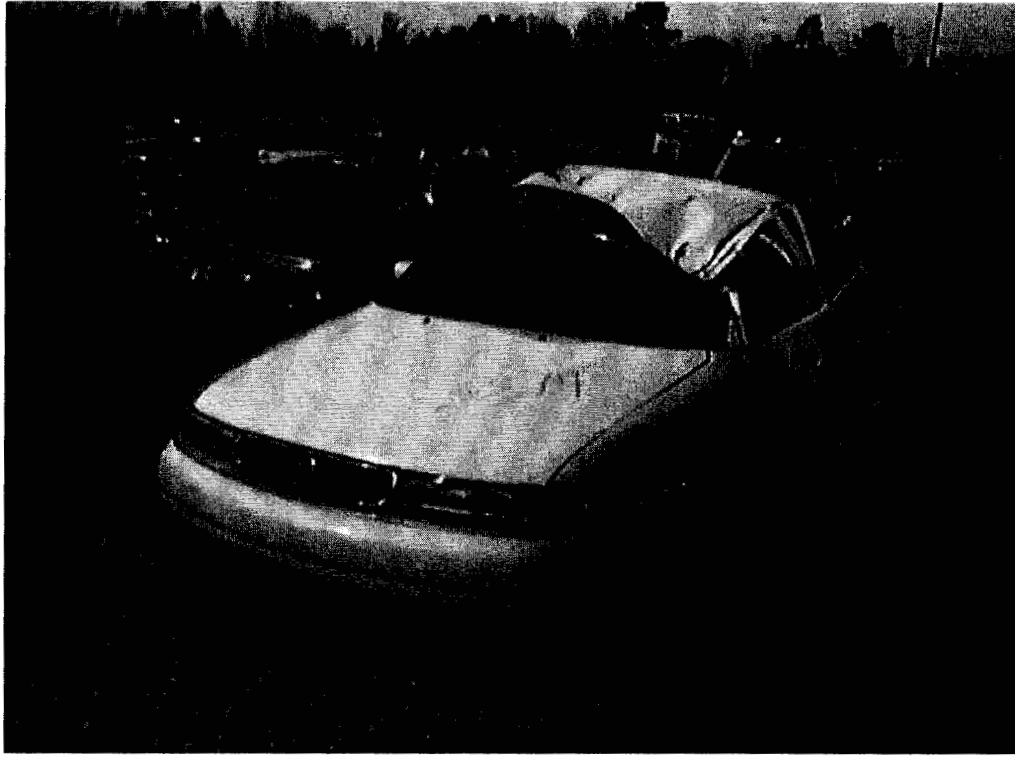
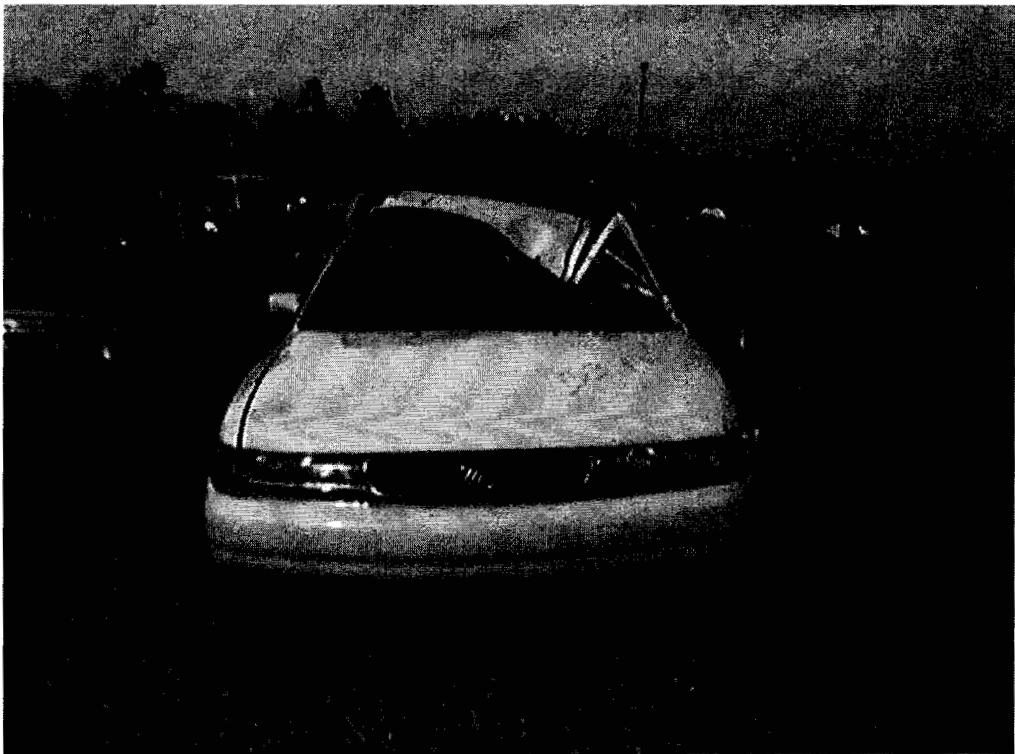
The vehicle initiated its rollover from the passenger side (the right side). The vehicle hit several trees as it rolled, causing an uncommon damage pattern to the driver's side of the vehicle. This included damage to the roof, side rail, door and side window frame, front header and A-pillar. Because the severity of the impact caused by the trees, the level of bending at the roof front left corner was almost catastrophic. The A-pillar bent at a composite angle just about at its middle. The top of the pillar bent almost to the vehicle's body. The side rail and front header bent downward to the same level. None of these components remained planar, except the roof, which bent downwards at a planar angle. The front windshield was holed but remained attached.

Figure 19. 1998-48-4, A-pillar Bending along its length (Oblique View)

Figure 20. Figure 19. 1998-48-4, A-pillar Bending along its length

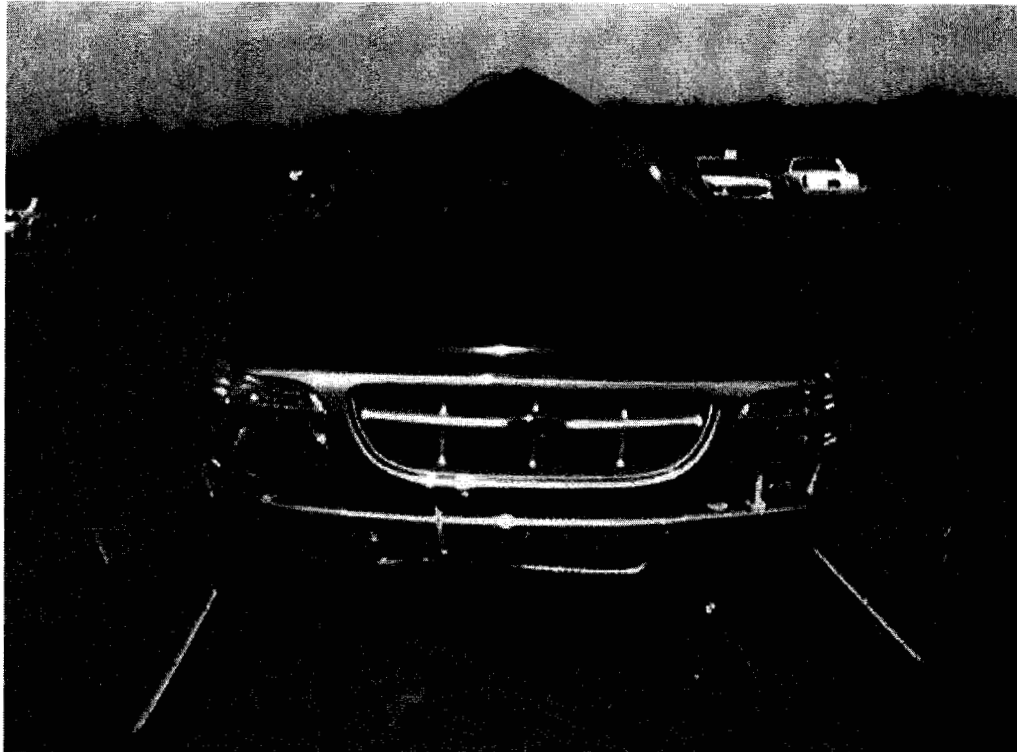
The case vehicle started its roll on the passenger side of the vehicle (the right side). The vehicle experienced almost a pure lateral rotation. During the rollover event, the vehicle contacted the ground on both sides of the vehicle. Ground contact caused damage to the A, B, and C-pillars, the roof, side rails, and the front header. Damage to the pillars involved bending with all of the pillars remaining straight. Similarly, the front header bent at its middle but remained planar on both sides of the bend. The roof also bent at its middle, longitudinally down the center of the vehicle, forming an upward "V." The front windshield was holed but remained attached to the vehicle.

Figure 23. 1997-73-26, Lateral (Inward) A-pillar Bending

Figure 24. 1997-73-26, Lateral (Inwards) A-pillar Bending

Figure 25. 1997-73-26, Lateral (Inwards) A-pillar Bending

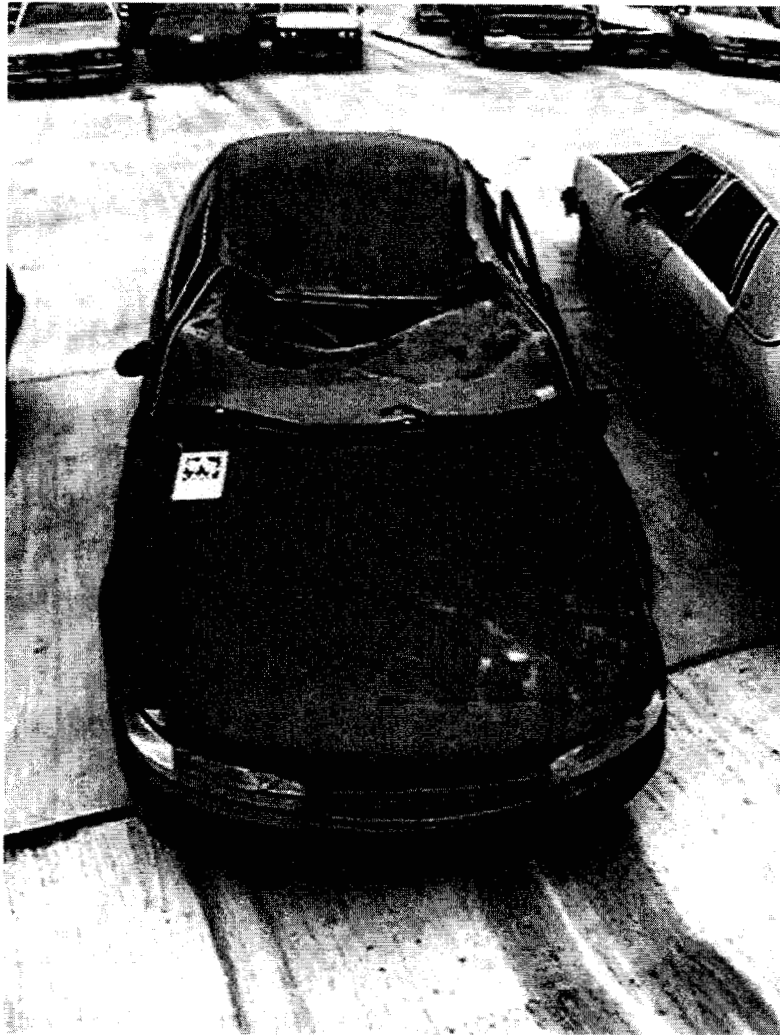
The case vehicle initiated the rollover event from the driver's side of the vehicle. As the vehicle rolled, contact was made with the driver's side of the vehicle and then the passenger side. During the rollover, the A-pillars on both sides of the vehicle bent midway along the length at a compound angle. The front header bent downward at both ends causing the roof to deform inward, although the roof side rails still remained straight. The windshield separated along the front header but remained attached along the other three sides.

Figure 29. 1999-49-140, Combination A-pillars Bending

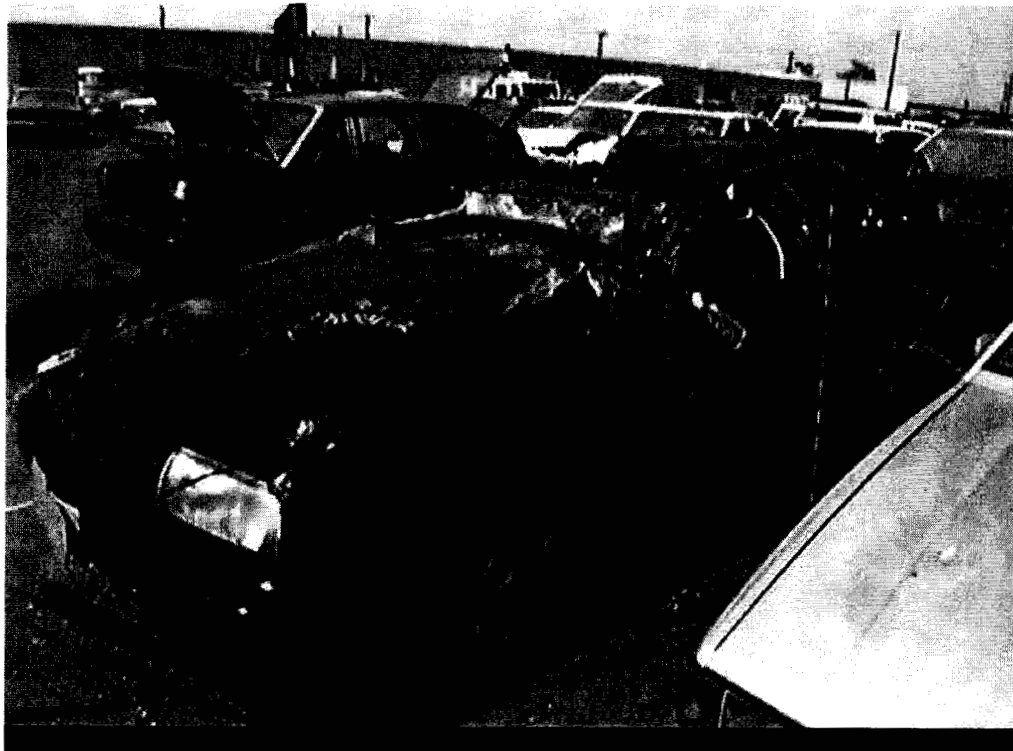
All six pillars bent inwards, with the degree of damage decreasing towards the rear of the occupant compartment. The B and C-pillars were bent along their length on both sides of the vehicle. The roof damage was considered catastrophic.

Figure 30. 1997-79-049, Catastrophic Roof Damage
