DEPARTMENT OF TRANSPORTATION
National Highway Traffic Safety Administration
Denial of Motor Vehicle Defect Petition

ACTION: Denial of a petition for a defect investigation.

Appendix - Petition Analysis - DP14-003

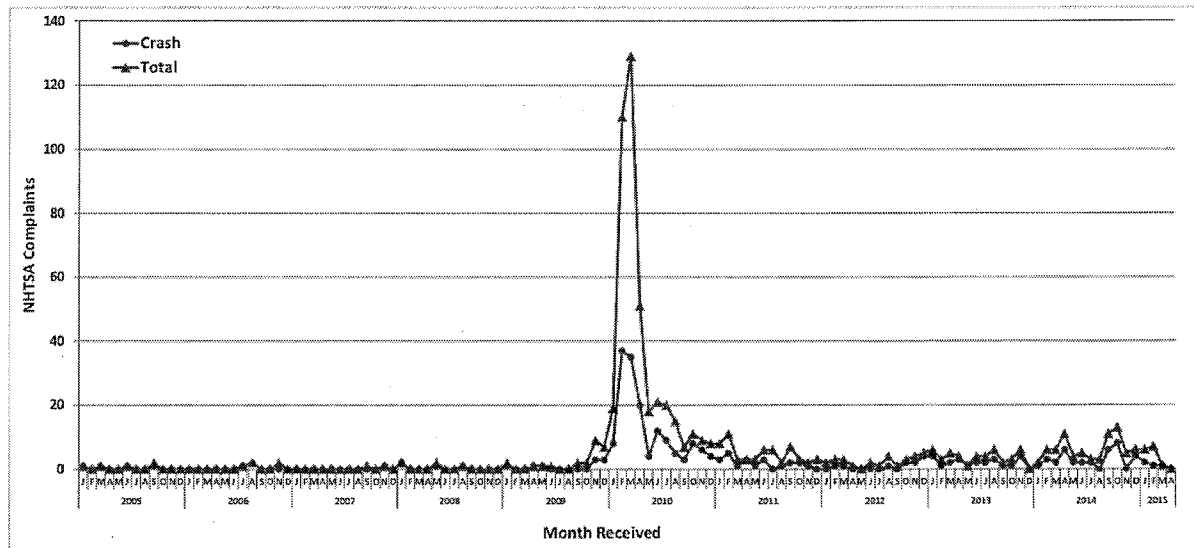
Figure 2. MY 2005-2015 Toyota Corolla Speed Control Complaints by Month Reported.

Complaints to ODI alleging SA related crashes are far less common. In the same period from 2004 through 2008 that the pedal error study identified over 2,400 pedal error related crashes in North Carolina police reports, ODI received less than 40 complaints alleging SA crashes in North Carolina in all light vehicles – or less than 2 percent of the number of crash incidents identified in the pedal error study. However, publicity can significantly increase ODI complaint volumes, as is evident for Toyota Corolla vehicles equipped with ETCS-i, which saw a 7,900% increase in speed control complaints alleging crashes and a 12,800% increase in total speed control complaints from the first quarter of 2009 to the first quarter of 2010, after news media coverage of Toyota's pedal entrapment and sticky pedal recalls (Figure 2). Each of these
