Re: 2004 - 2005 MY Toyota Highlander and Lexus RX330
2006 MY Toyota Highlander Hybrid and Lexus RX400h
Part 573, Defect Information Report

DEFECT INFORMATION REPORT

TECHNICAL INSTRUCTIONS
FOR
SPECIAL SERVICE CAMPAIGN 6LD
CENTER CONSOLE (FLOOR CARPET COVER)
RETAINING CLIP REPLACEMENT
FOR
2004 THROUGH 2005 MODEL YEAR RX 330 AND
EARLY 2006 MODEL YEAR RX 400h

2004 THROUGH 2005 HIGHLANDER AND
EARLY 2006 HIGHLANDER HV

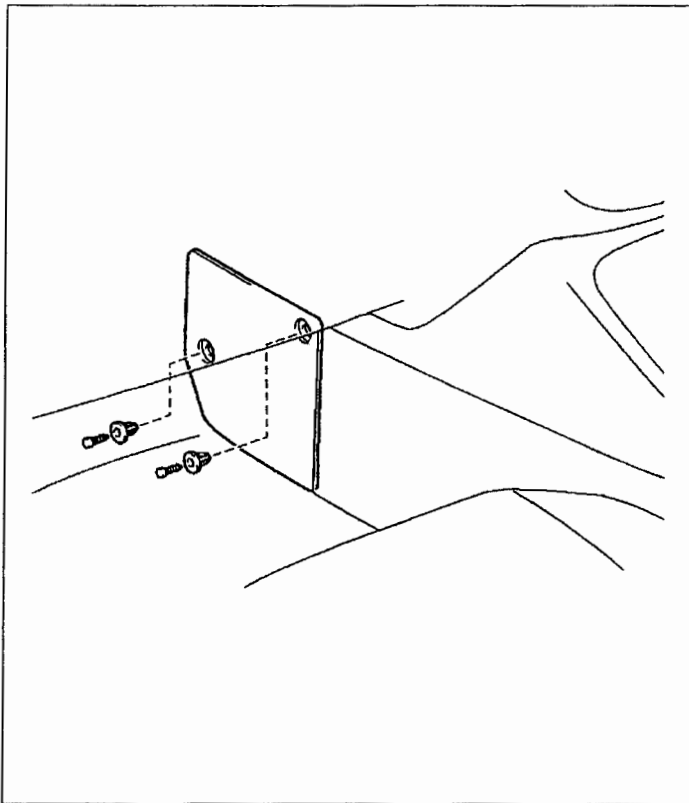
A. REPLACE THE FLOOR CARPET COVER RETAINING CLIPS

In certain 2004 through 2005 model year Japan produced RX 330 and early 2006 model year RX 400h vehicles, due to improper installation, the two Retaining Clips for the driver's side forward Center Console (Floor Carpet Cover) can become loose. If both clips separate from the Floor Carpet Cover, the cover may lean toward the accelerator pedal, causing interference with the accelerator pedal rod.

1. REMOVE EXISTING CLIPS

- a) REMOVE, *DESTROY*, AND *DISCARD* THE 2 CLIPS.

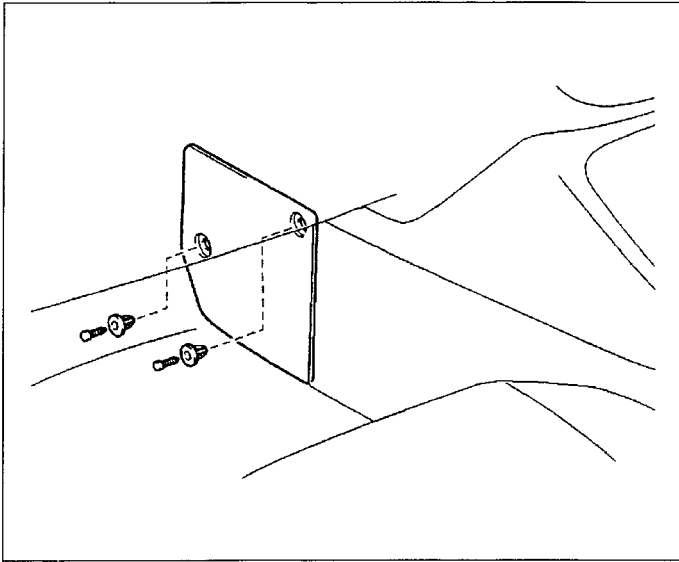
A. REPLACE THE FLOOR CARPET COVER RETAINING CLIPS

In certain 2004 through 2005 model year Highlander and early 2006 model year Highlander Hybrid (HV) vehicles, due to improper installation, the two Retaining Clips for the driver's side forward Center Console (Floor Carpet Cover) can become loose. If both clips separate from the Floor Carpet Cover, the cover may lean toward the accelerator pedal, causing interference with the accelerator pedal rod.

1. REMOVE THE CLIPS

- a) Remove, **destroy** and **discard** the 2 clips.

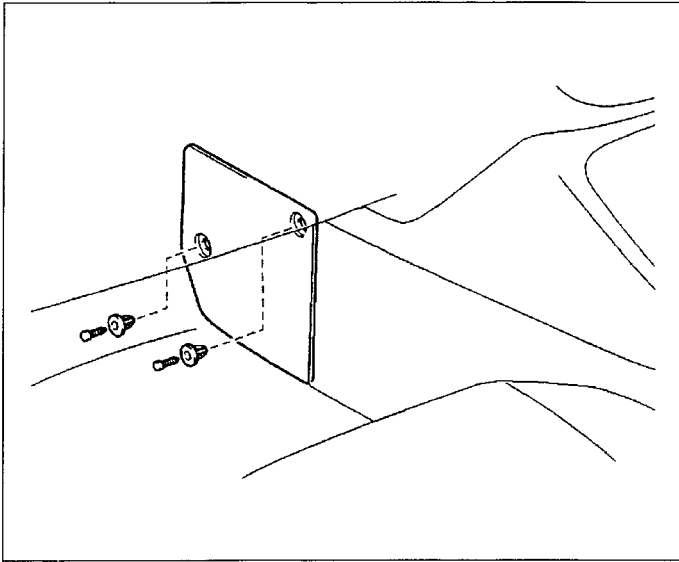
A. REPLACE THE FLOOR CARPET COVER RETAINING CLIPS

In certain 2004 through 2005 model year Highlander and early 2006 model year Highlander Hybrid (HV) vehicles, due to improper installation, the two Retaining Clips for the driver's side forward Center Console (Floor Carpet Cover) can become loose. If both clips separate from the Floor Carpet Cover, the cover may lean toward the accelerator pedal, causing interference with the accelerator pedal rod.

1. REMOVE THE CLIPS

- a) Remove, **destroy** and **discard** the 2 clips.

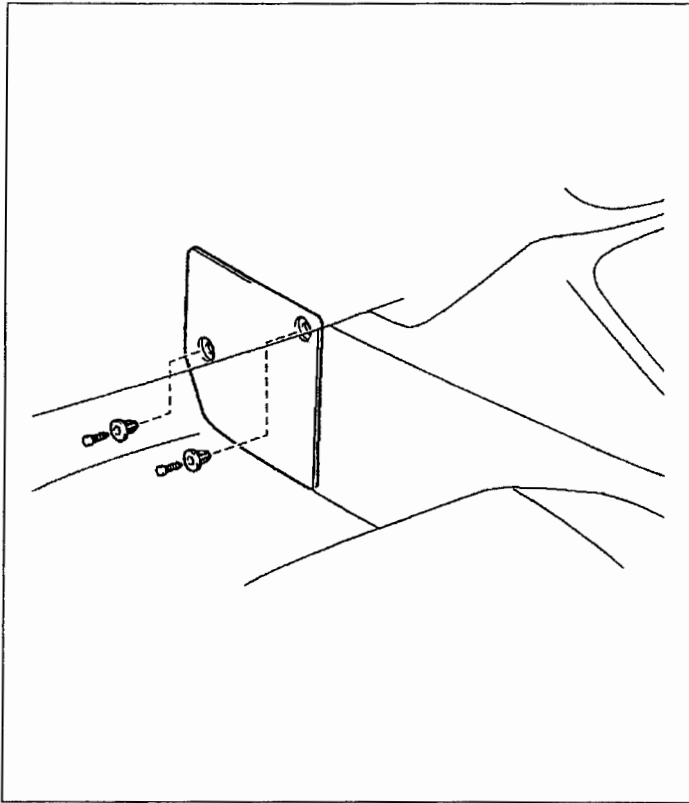
A. REPLACE THE FLOOR CARPET COVER RETAINING CLIPS

In certain 2004 through 2005 model year Japan produced RX 330 and early 2006 model year RX 400h vehicles, due to improper installation, the two Retaining Clips for the driver's side forward Center Console (Floor Carpet Cover) can become loose. If both clips separate from the Floor Carpet Cover, the cover may lean toward the accelerator pedal, causing interference with the accelerator pedal rod.

1. REMOVE EXISTING CLIPS

- a) REMOVE, *DESTROY*, AND *DISCARD* THE 2 CLIPS.
