Safety Research & Strategies, Inc.

Are Floor Mats the Cause of Sudden Unintended Acceleration in Toyotas?

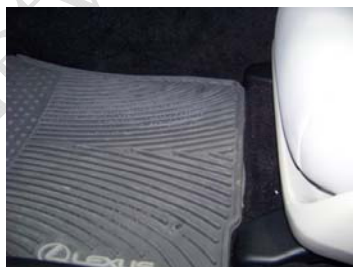
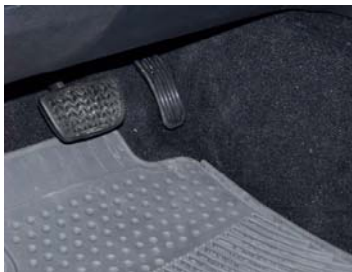
When properly installed using the retaining clips provided, the floor mat **cannot** interfere with the accelerator as show in this 2009 Lexus ES350:

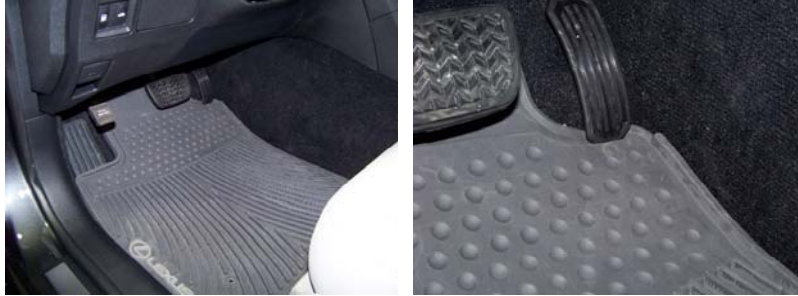
If the floor mat is not retained by the clips and the mat is misplaced closer toward the accelerator, it can interfere with the accelerator. In the photos below, note the lower edge of the accelerator pedal caught in the groove of the all-weather mat.

In order for the accelerator to stick in the floor mat groove, it must be pressed all the way down to the floorboard.

However, in most instances when the accelerator gets caught, the return spring force of the pedal is strong enough to cause it to release, particularly when the mat is jarred and / or the pedal is being manipulated the pedal will return to its nominal position.

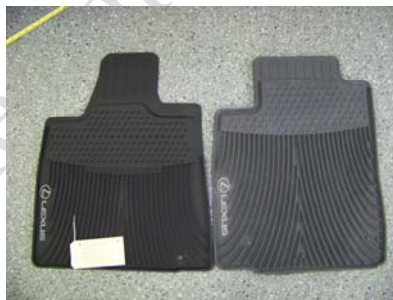
A side by side comparison of the recalled ES350 and redesigned ES350 floor mats shows some of these differences.

The two most obvious changes to the floor mat are that the cut out around the accelerator is larger and the rib that was catching the lower edge of the accelerator pedal has been removed.

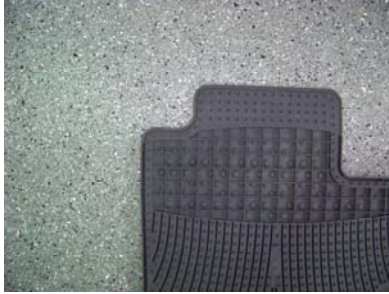
Recalled ES350 Mat

Another significant change was made to the underside of the floor mat at the accelerator cut-out (below). There are ridges designed on the underside of the mat to make the area near the bottom of the accelerator pedal more flexible. On the recalled floor mat, this area is very stiff, which can contribute to retention of the accelerator pedal.

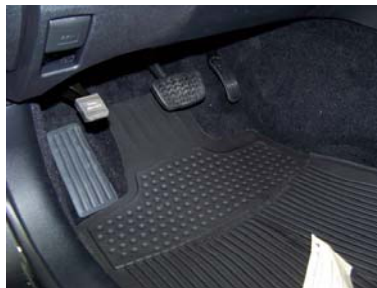
The new floor mat has much larger cut-out area around the floor mat and is unlikely to entrap the accelerator if it is fully depressed.

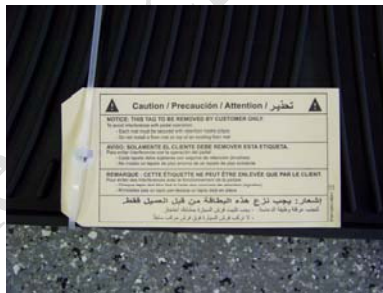
The redesigned floor mat also includes a caution regarding interference with pedal operation.
