#### **EWR D&I ANNOTATION**

Ms. Gay Kent General Motors Corp. Mail Code 480-210-G11 30001 Van Dyke Warren, MI 48090 NVS-217ph DI07-044

## DI07-044 88 210872965 – 624620 2005 CHEVROLET COBALT

Title: FATAL MOTOR VEHICLE ACCIDENT

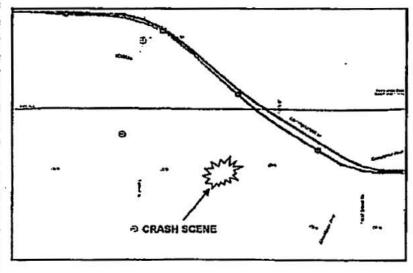
Upon my arrival on scene I viewed the scene with Deputy Mark Sommers and Trooper William Traynor. The roadway leading up to the crash scene was inspected for any indication as to why the vehicle left the road. The first evidence that could be observed was gravel from the shoulder scattered onto the eastbound lane approximately 195 feet west of the driveway at 1237 CTH N. This was most likely caused by the tires of the

they left the roadway. There were rolling tire marks in the south ditch that lead up to the edge of the driveway. The vehicle then struck the sloped driveway embankment and vaulted approximately 59 feet through the air. The vehicle landed and traveled another 82 feet before striking a telephone junction box. The vehicle then traveled an additional 46 feet before striking a grouping of two trees, and rotating approximately degrees. The vehicle came to rest just north of the trees, facing south in the south ditch.

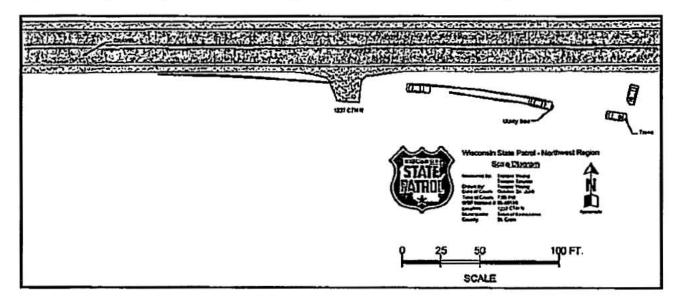
#### COLLISION SEQUENCE

As the vehicle traveled down a slight grade her vehicle went onto the south shoulder and into the south ditch. When the vehicle approached the driveway at house number 1237 it launched off of the west edge of the driveway and was airborne for approximately 59 feet. The vehicle landed and traveled approximately 82 feet before striking a telephone junction box and knocking it down. The vehicle then traveled another 46 feet through some brush before striking two larger trees. The vehicle then rotated clockwise approximately 94 degrees while traveling another 14 feet before coming to rest.

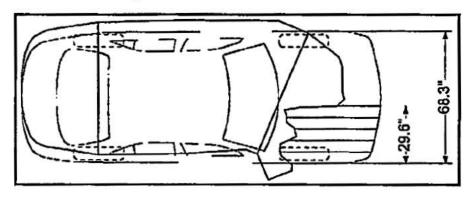
On November 6, 2006, Trooper Traynor and myself went to the St. Croix County Impound Lot to measure the damage profile of the vehicle. Using the State Patrol's Geodimeter 610 Total Station, measurements of the vehicle were taken to determine the amount of deformation that was caused by the collision with the trees.

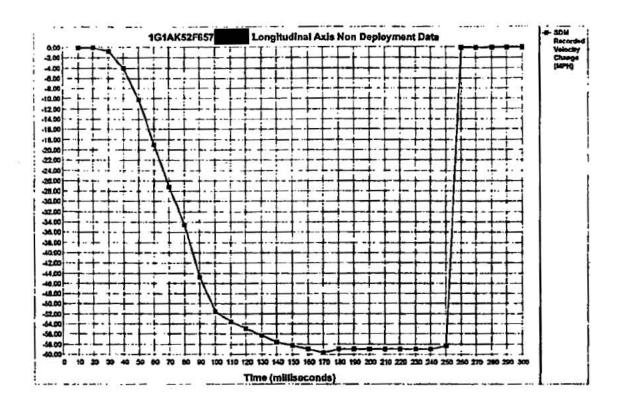
Time (miliseconds)	10	20	30	40	50	80	70	80	80	100	110	120	130	140	150
Longitudinal Axis Recorded Velocity	0.00	0.00	-0.68	-1.07	-10.17	-18.98	-27.11	-34.57	-44.74	-51.52	-63.55	-64.90	-56.26	-57.62	-68.29
Time (milliseconds)	160	170	180	190	200	210	220	230	240	250	260	270	290	290	300
Longitudinal Axis Recorded Velocity	-58.97	-59.65	-60.97	-68.97	-58.97	-58.97	-58.97	-5a.97	-58.97	-68.29	0.00	0.00	0.00	0.00	0.00

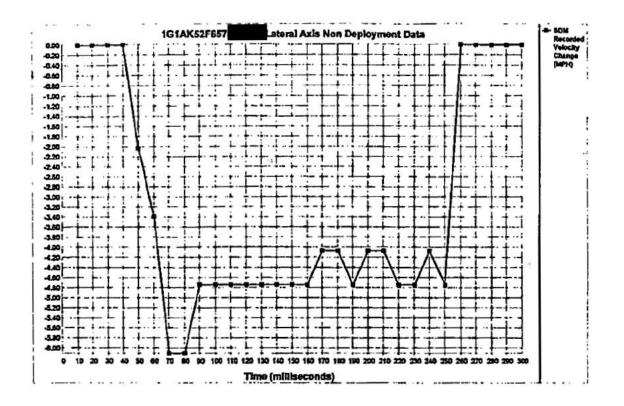
Time (miliseconds)	10	20	30	40	50	50	70	80	80	100	110	120	130	140	150
Lateral Axis Recorded Velocity Change (MPH)	6.00	0.00	0.00	0.00	-203	-3.39	-0.10	-0.10	-174	-1.74	-474	4.74	-474	-1.74	-4.74
Time (milliseconds)	160	170	180	190	200	210	220	230	240	250	260	270	280	290	300
Lateral Axis Recorded Velocity Change (MPH)	-474	4.07	-1.07	-4.74	-1.07	-4.07	-4.74	-4.74	-1.07	-1.74	0.00	0.00	0.00	0.00	0.00
