**An Examination of the National Highway  
Traffic Safety Administration and the  
National Aeronautics and Space  
Administration Engineering Safety Center  
Assessment and Technical Evaluation of  
Toyota Electronic Throttle Control (ETC)  
Systems and Unintended Acceleration**

**May 23, 2011**

*The Safety Record*

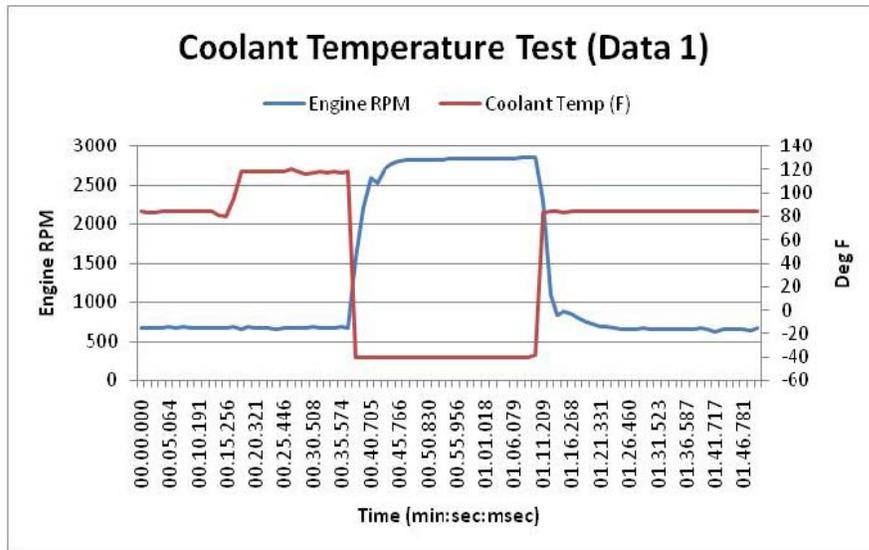
throttle opening jumped, when there should be a rate-of-change limit. A coolant temperature model should be used as a comparison. Toyota's On-Board-Diagnostics II (OBD II—an emissions diagnostic testing standard) should use such a model to detect a stuck thermostat. A failed coolant temperature sensor is usually a one-trip electrical fault. There should also be a thermostat rationality fault. The NESC team didn't discuss idle speed DTC's at all – even though they are related. As shown in the Figure 6.6.3.7-1 from the report (below), the ECT sensor input is varied rapidly from approximately 120F to near -40°F resulting in a 2000 RPM change.

This engine temperature change would not happen in the real world. The NESC team mentions this, but later dismisses it. What would happen if this type of circuit fault were to occur with the vehicle in gear? *Significant torque output, unrequested by the driver, causing UA.*
