**National Highway
Traffic Safety
Administration**

Subject: FINAL REPORT: "2007 Lexus ES-350 Unintended
Acceleration"

VRTC MEMORANDUM REPORT EA07-010
VRTC-DCD-7113

2007 Lexus ES-350 Unintended Acceleration

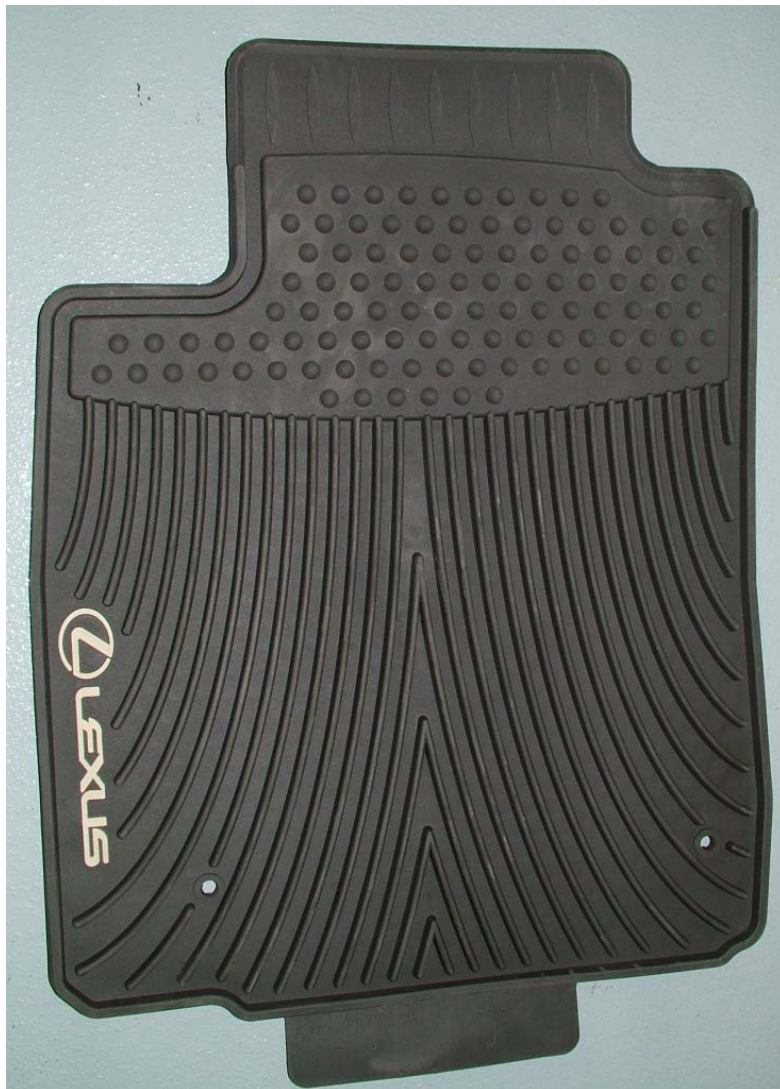
pedal revealed that the one-piece, non-articulating accelerator pedal assembly was easily entrapped in the groove of the rubber all-weather floor mat (Figures 2 and 3) if the rubber mat was not properly secured with at least one of the two retaining hooks (Figure 4). In many observed ES-350's, the rubber mats were stacked on top of the existing carpeted floor mats, which prevented attachment of the rubber mats and facilitated the interference failure mode. A warning is embossed on the front of the floor mat that reads "Do not place on top of existing floor mats". Very few owners interviewed were able to find or read this warning (see Figure 5).

Figure 2 – Lexus All-weather Floor Mat with Retaining Hook Holes at the Bottom

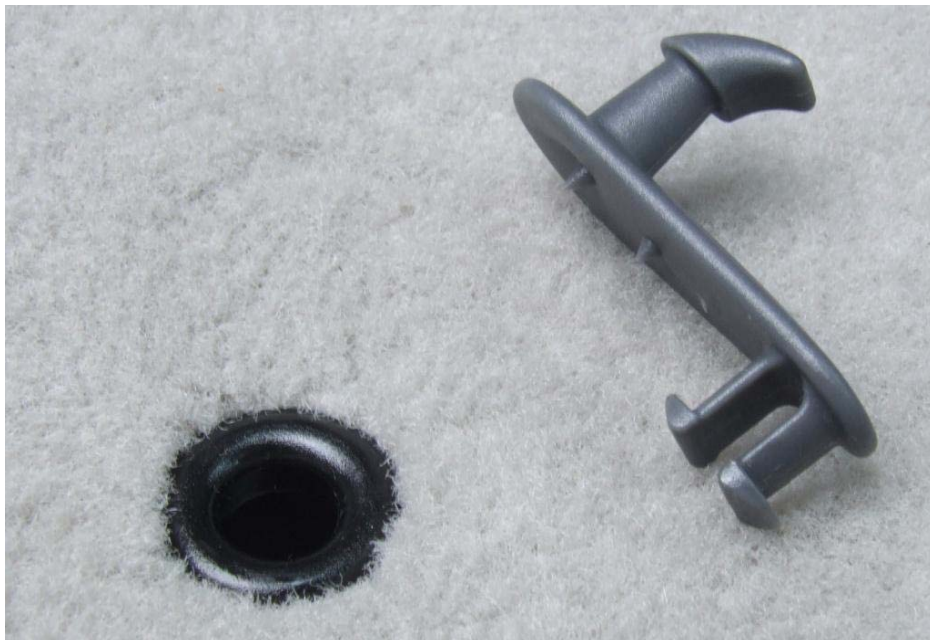
Figure 4 –Floor Mat Retaining Clip and Carpet Receiving Eyelet

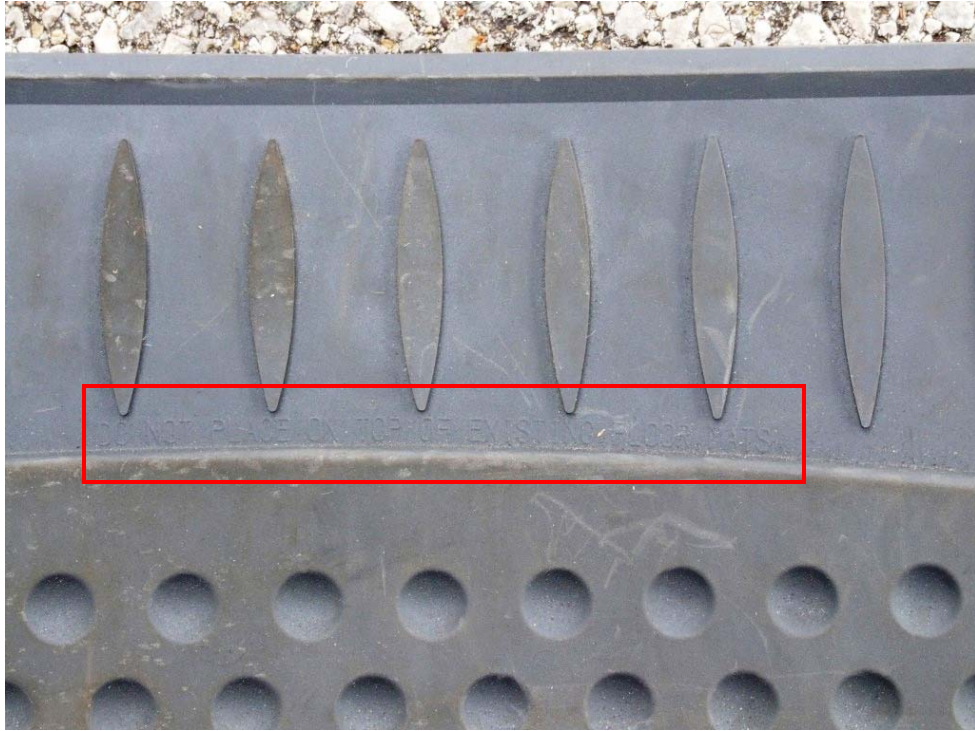
Figure 5 – Embossed Warning On Floor Mat States “Do Not Place On Top of Existing Floor Mats”

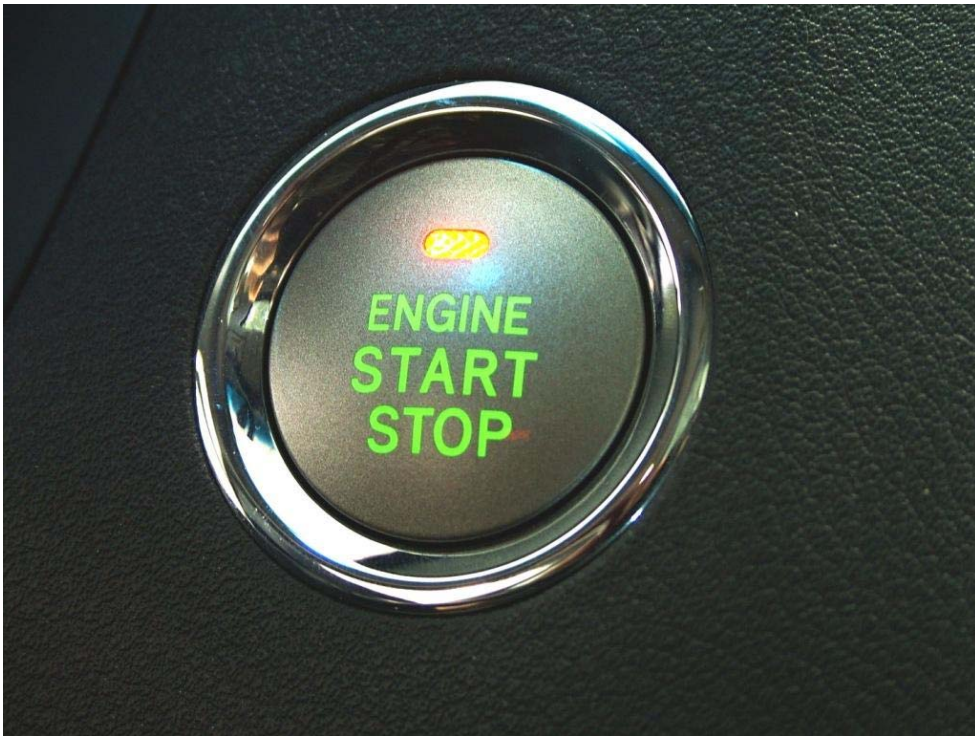
- 3.3.2** Turning off the ignition - In place of an ignition key, the ES-350 uses an ignition button that removes the ability to instantaneously shut off the engine in the event of an emergency while the vehicle is in motion (see Figure 6). It was found that depressing and holding the button will eventually turn off the engine after three seconds. Through the survey it was learned that the button delay operation is not widely known by owners and because of this, drivers found themselves unable to turn off the engine when the vehicle was in motion. The owner's manual makes general mention of the operation, but there is no indication of the three second hold requirement.

- The owner survey indicated the 3 second delay in the operation of the ignition button is not widely known by owners and because of this, drivers found themselves unable to turn off the engine when the vehicle was in motion.

Figure 6 - Push Button Ignition Replaces Conventional Key

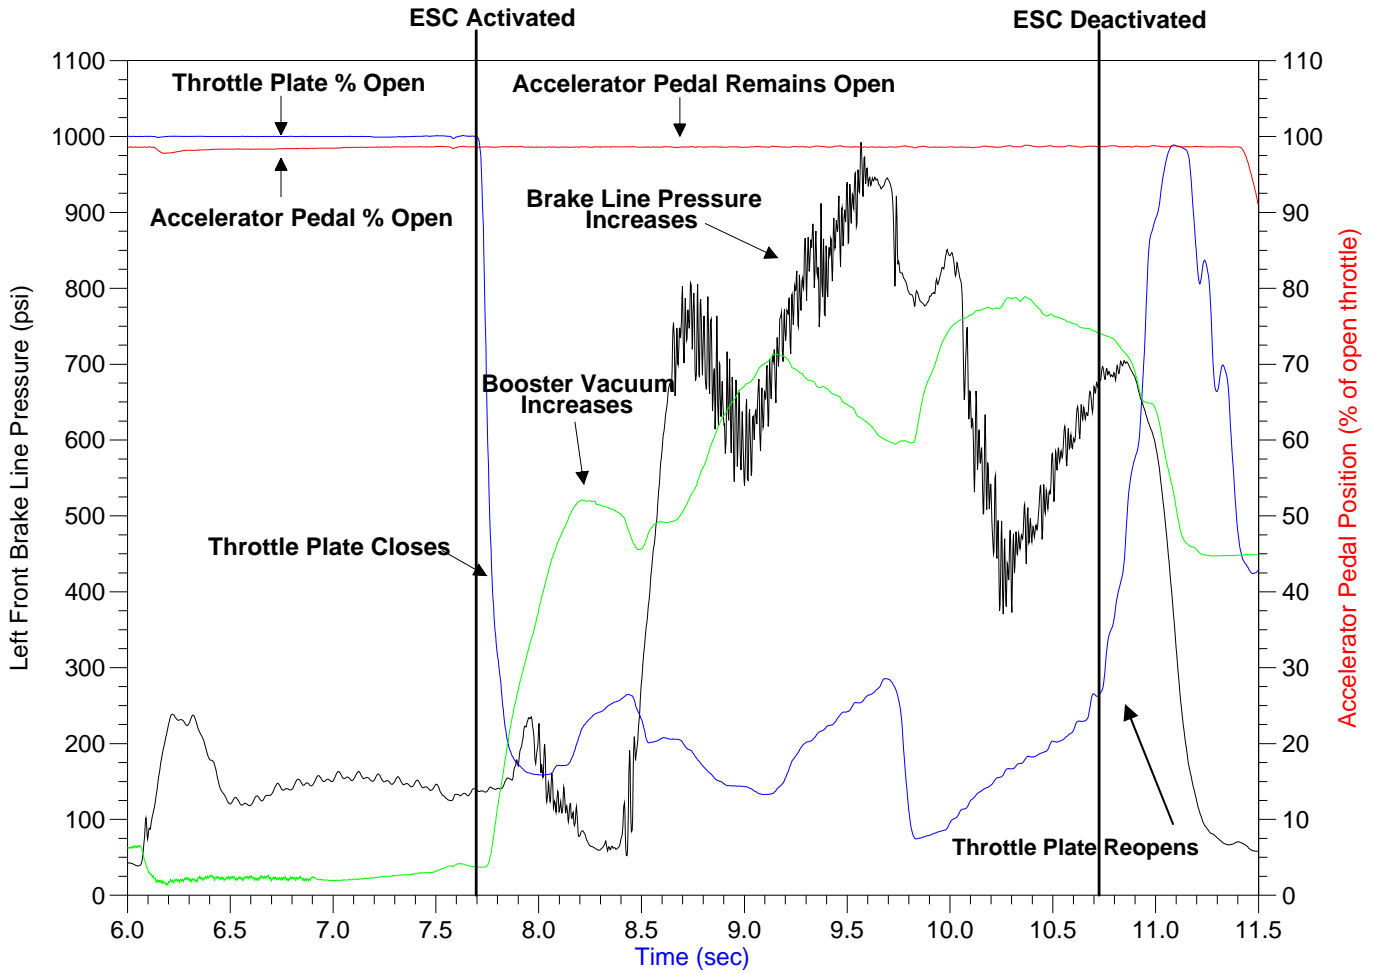
- 3.3.4** Activation of Electronic Stability Control (ESC) - It was discovered that if an emergency maneuver is executed that activates the Electronic Stability Control, such as steering around a sharp curve while traveling at an excessive speed, the electronic throttle is temporarily electronically closed by the vehicle control module regardless of the accelerator pedal position. With the throttle plate closed, vacuum quickly returns to the brake booster and provides a significant increase in braking capability (see Figure 8). Additionally, ESC has the capability to automatically apply hydraulic pressure to the service brakes to aid in slowing the vehicle. When the emergency maneuver is concluded however, the ESC system returns to a passive state, and the throttle again returns to an open condition leading to further unwanted acceleration.

- Brake pedal force in excess of 150 pounds was required to stop the vehicle, compared to 30 pounds required when the vehicle is operating normally.
 - ESC activation may restore vacuum to the brake booster, providing a significant increase in braking capability, but only until ESC activity ceases.

Figure 8 – Data Acquired from Lexus During Testing Indicates Engine Throttle is Overridden During ESC
