# Tire Aging:

## A Summary of NHTSA's Work

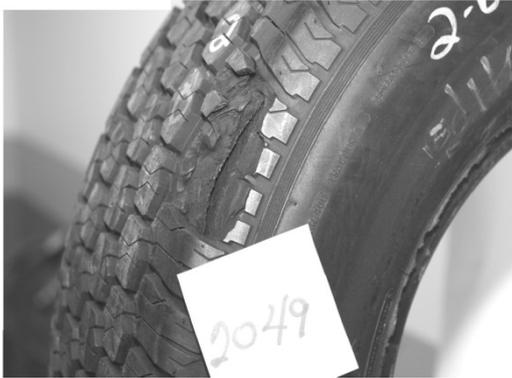
Belt edge separation

- Passenger car and light truck tires were aged for 3, 4 and 5 weeks.
- OE and replacement tires were tested.
- Passenger car tires maintained material properties and roadwheel performance better than the light truck tires (FMVSS No. 119-compliant).
- Failure modes: belt edge separation, separation between belts, loss of tread and belt, tread element tear/chunk out, innerliner detachment, sidewall split and rupture, white sidewall separation, tread and belt separation, black sidewall separation.

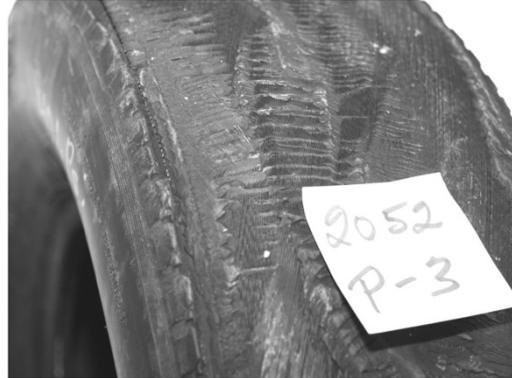
Loss of tread and belt

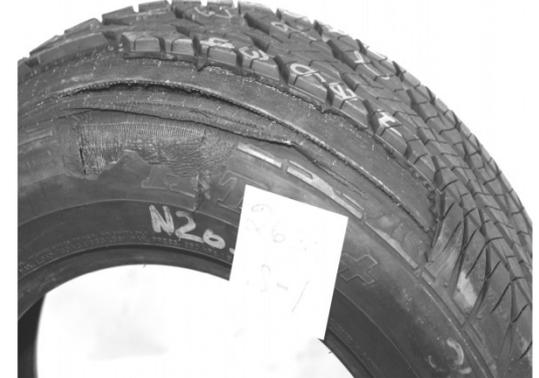
Photo #17 Tire 2511 Group B-9

Tread and belt separation

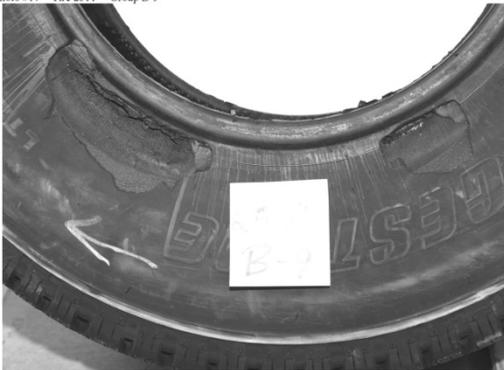
Black sidewall separation

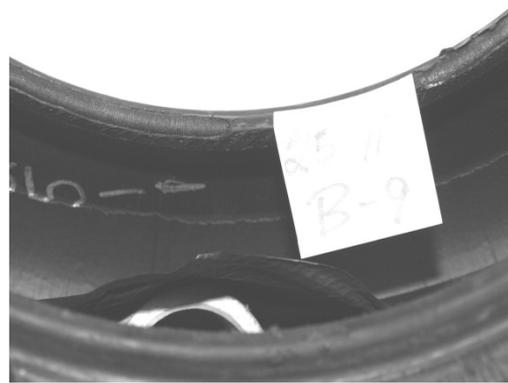
Photo #19 Tire 2511 Group B-9

Innerliner detachment

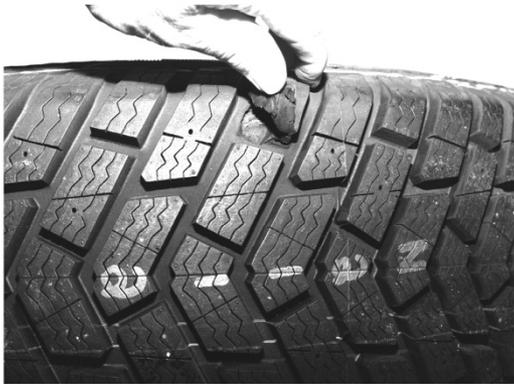
Tread element tear

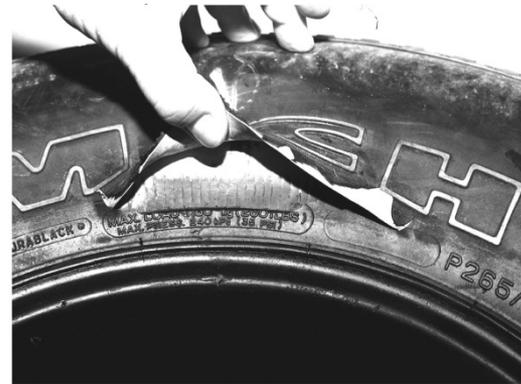
White sidewall separation

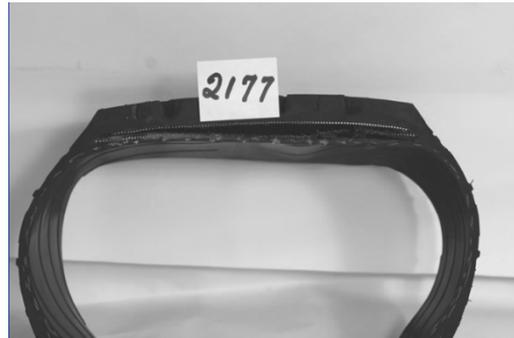
Separation between belts

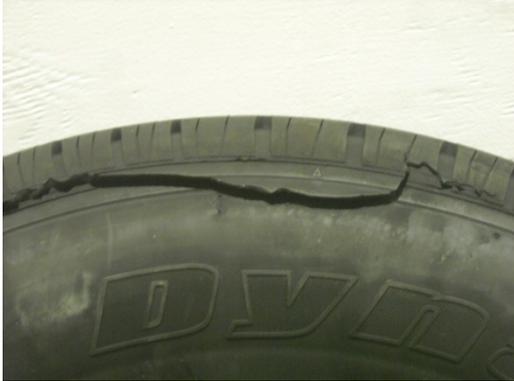
Tread separation at shoulder

- Passenger car and light truck tires were aged for 5 weeks.
- Only replacement tires were tested.
- FMVSS No.139-compliant tires were tested, both passenger car tires and light truck tires.
- Failure modes: Cracking in the shoulder, cracking in tread groove, cracking in base of tread at shoulder, tread separation at shoulder. Smaller percentages of tread shoulder blister, tread chunking, cracking in sidewall, sidewall delamination, sidewall bubbles, sidewall deformation at splice.

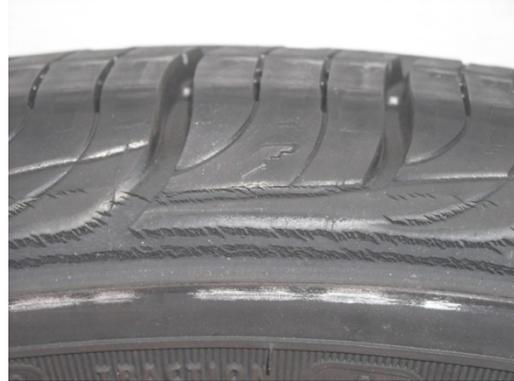
Cracking in shoulder

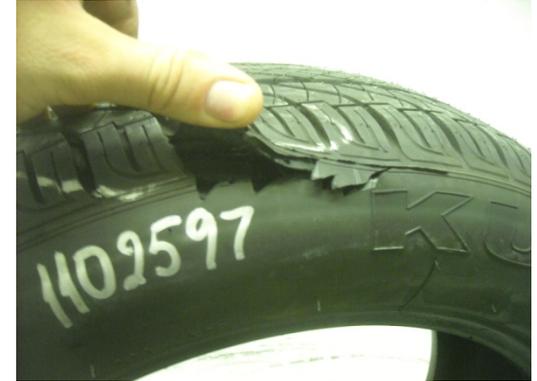
Tread shoulder cracking out of oven

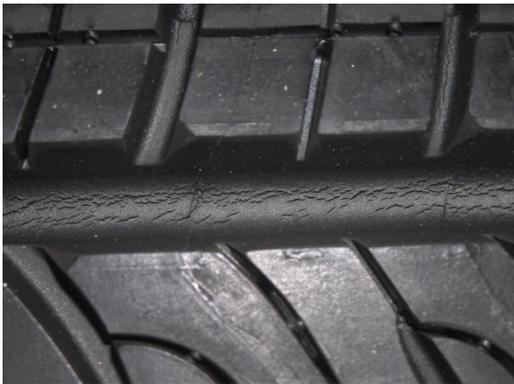
Cracking in tread groove

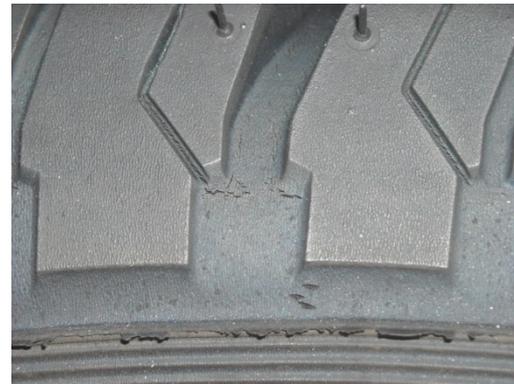
Cracking at base of tread shoulder

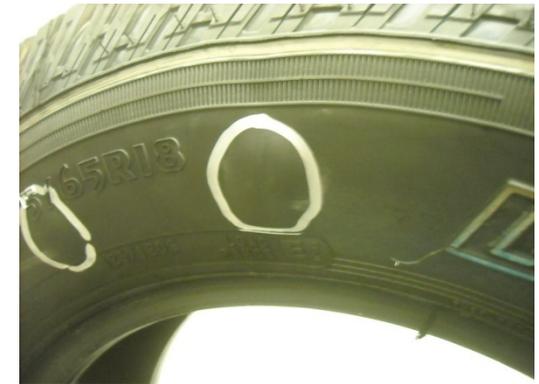
Sidewall bubbles
