Subject: Revised Ford Motor Company (Ford) Defect Information Report Regarding
Recall No. 09S09

SAFETY RECALL 09S09 AFFECTED VEHICLES

49 CFR Part 573 -- DEFECT INFORMATION REPORT
FORD RECALL 09S09

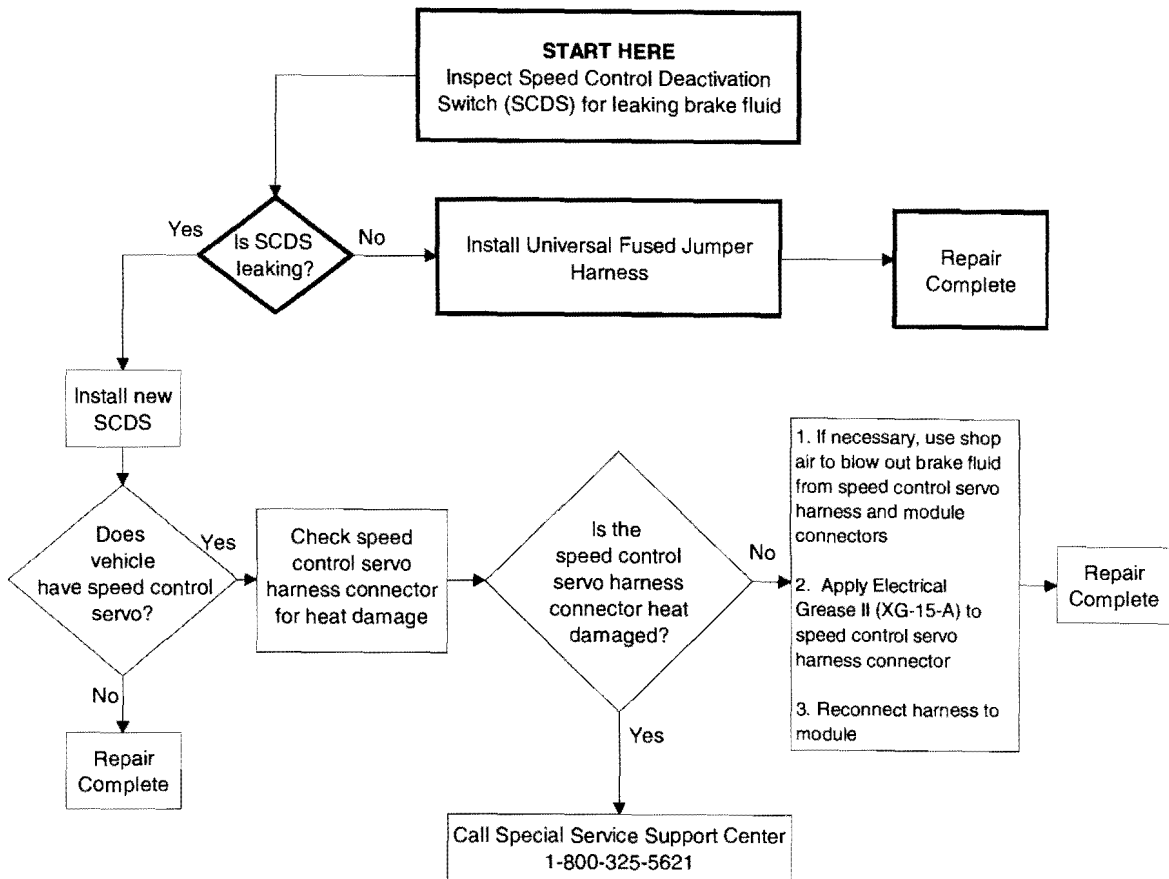
Flow Chart #1 shows the repair procedure for all affected vehicles except 1999 through 2003 Windstar vehicles.

This Safety Recall involves an inspection of the Speed Control Deactivation Switch (SCDS) harness connector for the presence of brake fluid contamination. If no brake fluid is present, install the universal fused jumper harness. If brake fluid is present, replace the SCDS and inspect the speed control servo harness connector for heat damage. See Flow Chart #2 on page 3.

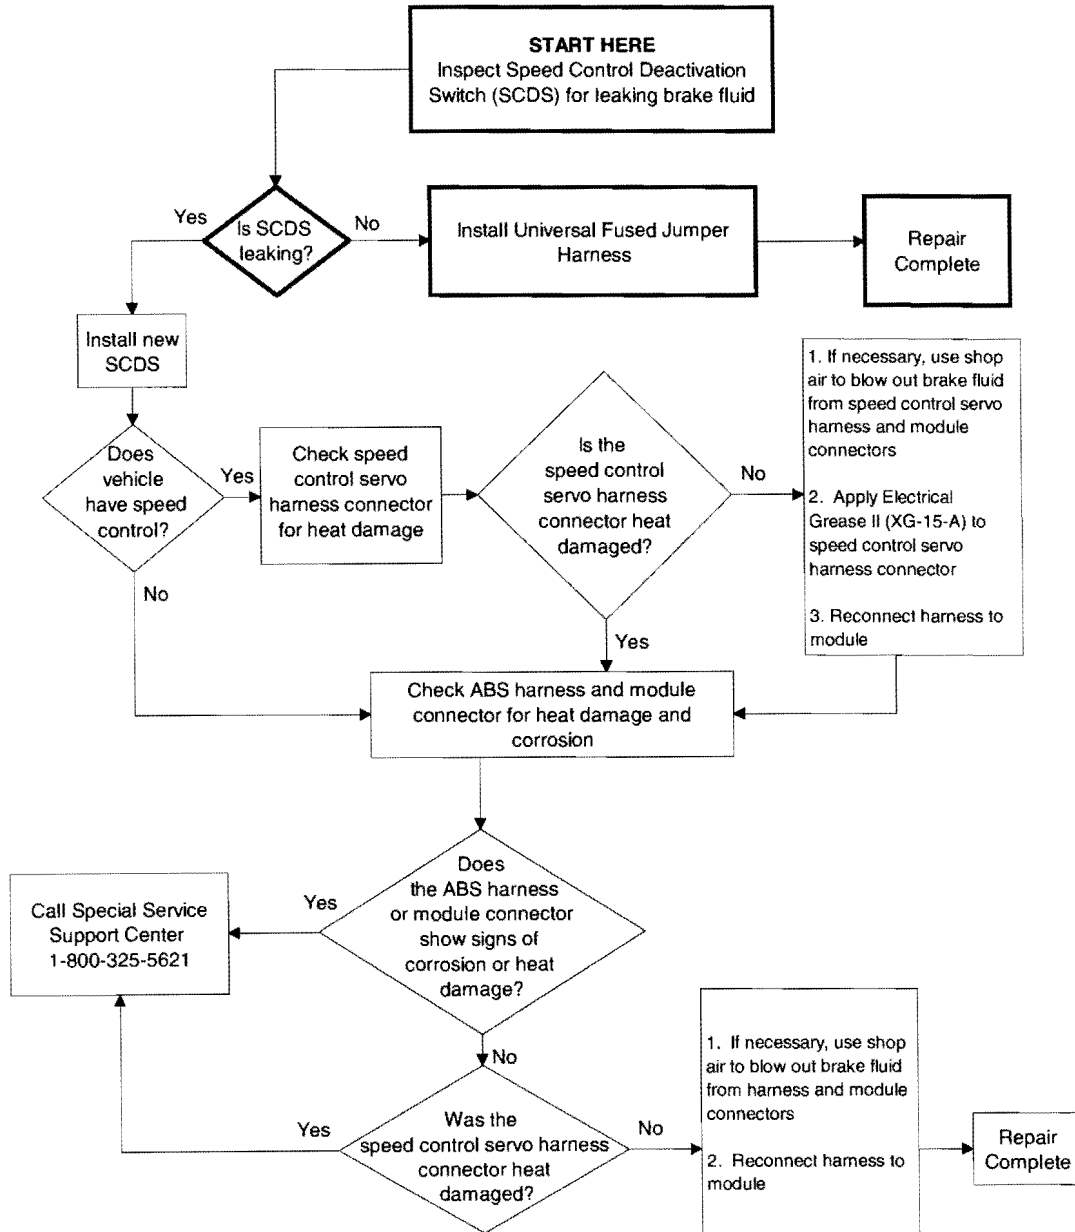
Flow Chart #2 shows the repair procedure for 1999 through 2003 Windstar vehicles.

In addition, for 1999 through 2003 Windstar vehicles, the repair includes an inspection of the Anti-lock Brake System (ABS) connectors. See Flow Chart #2 on page 3.
