# Toyota Sudden Unintended Acceleration

February 5, 2010

**Safety Research & Strategies, Inc.**  
340 Anawan Street / Ste. 200  
Rehoboth, MA 02769  
Ph. 508-252-2333, Fax 508-252-3137  
[www.safetyresearch.net](http://www.safetyresearch.net)

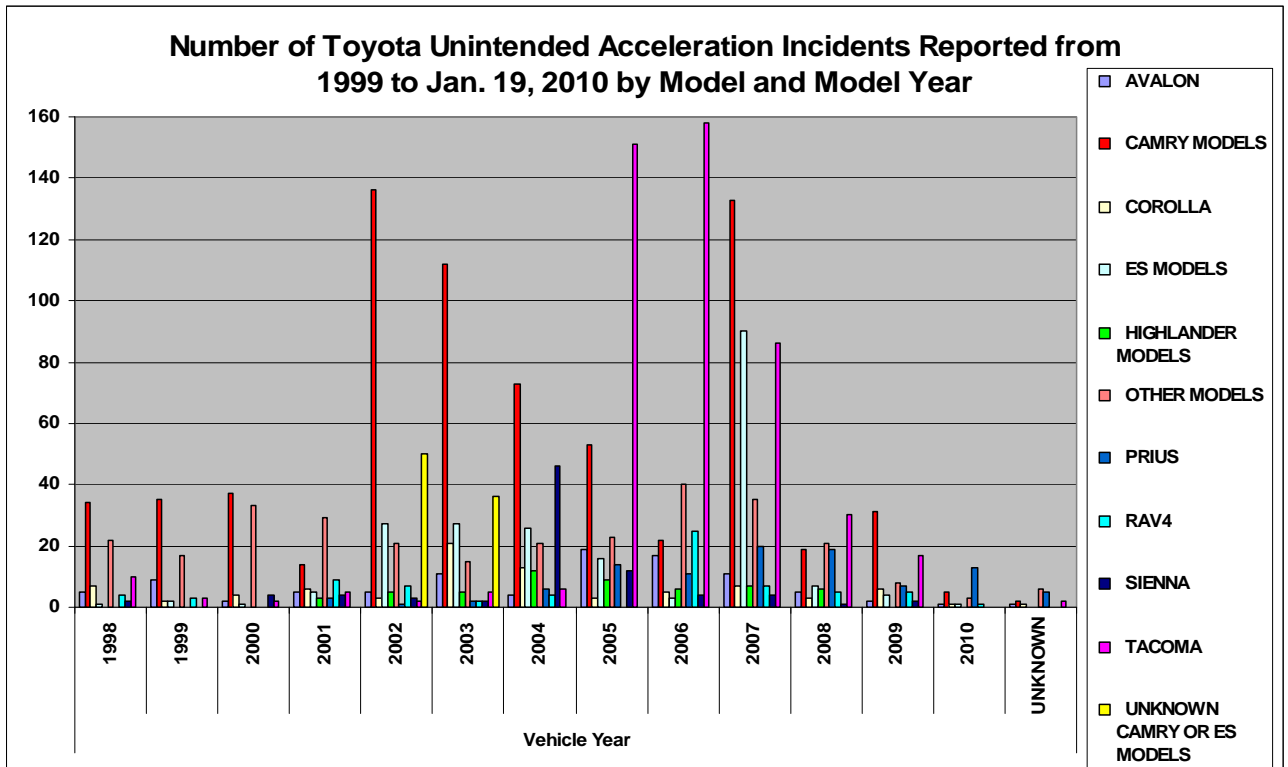
**Figure 1**

CAMRY MODELS	12
ES MODELS	5
HIGHLANDER MODELS	1
IS MODELS	1

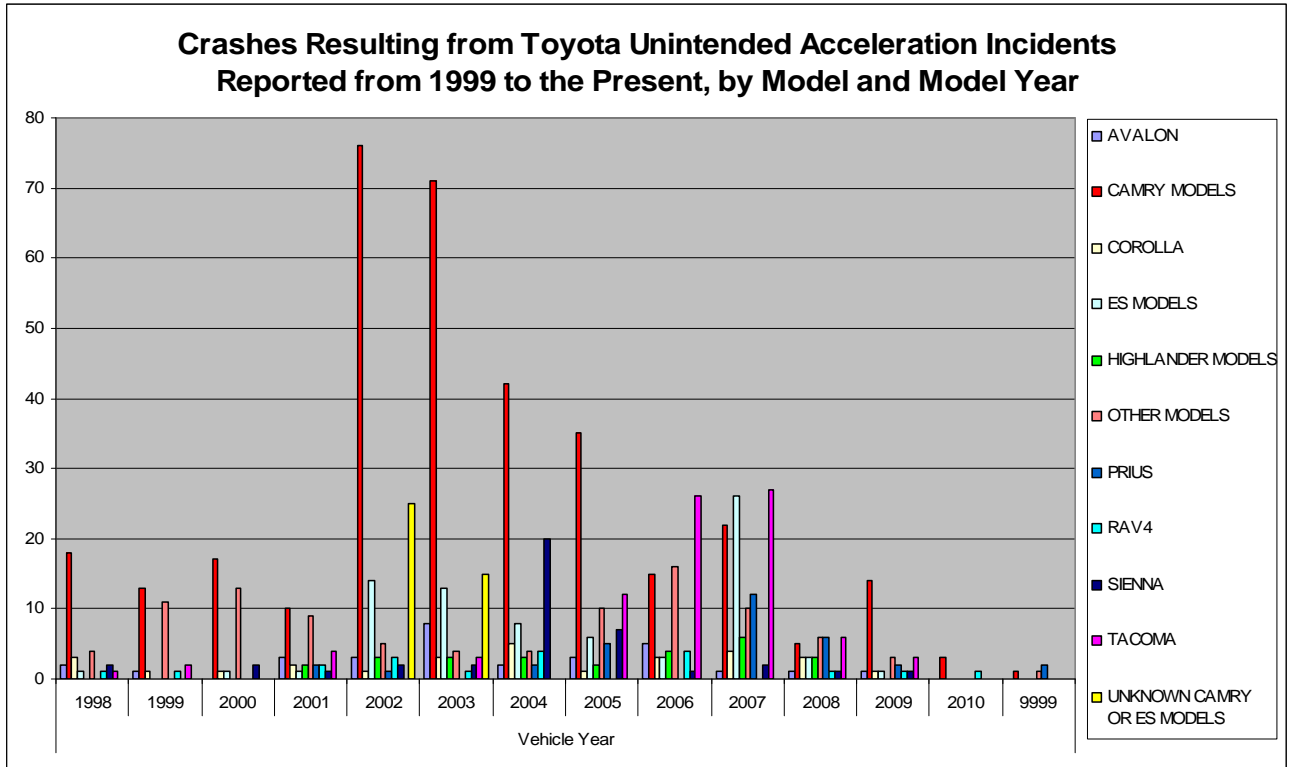
Figure 2

[Note: In order to improve visibility for the graphs, we have combined vehicle models for which there are fewer than fifty reported incidents across all years with “Other Models” category.]
