**National Highway
Traffic Safety
Administration**

Subject: **ACTION:** Submittal Roof Crush Analysis Using
1997-2001 NASS Case Review Report, by the
Department of Applied Research, to Docket No.
NHTSA-1999-5572 - 95

Roof Crush Analysis Using 1997-2001 NASS Case Review

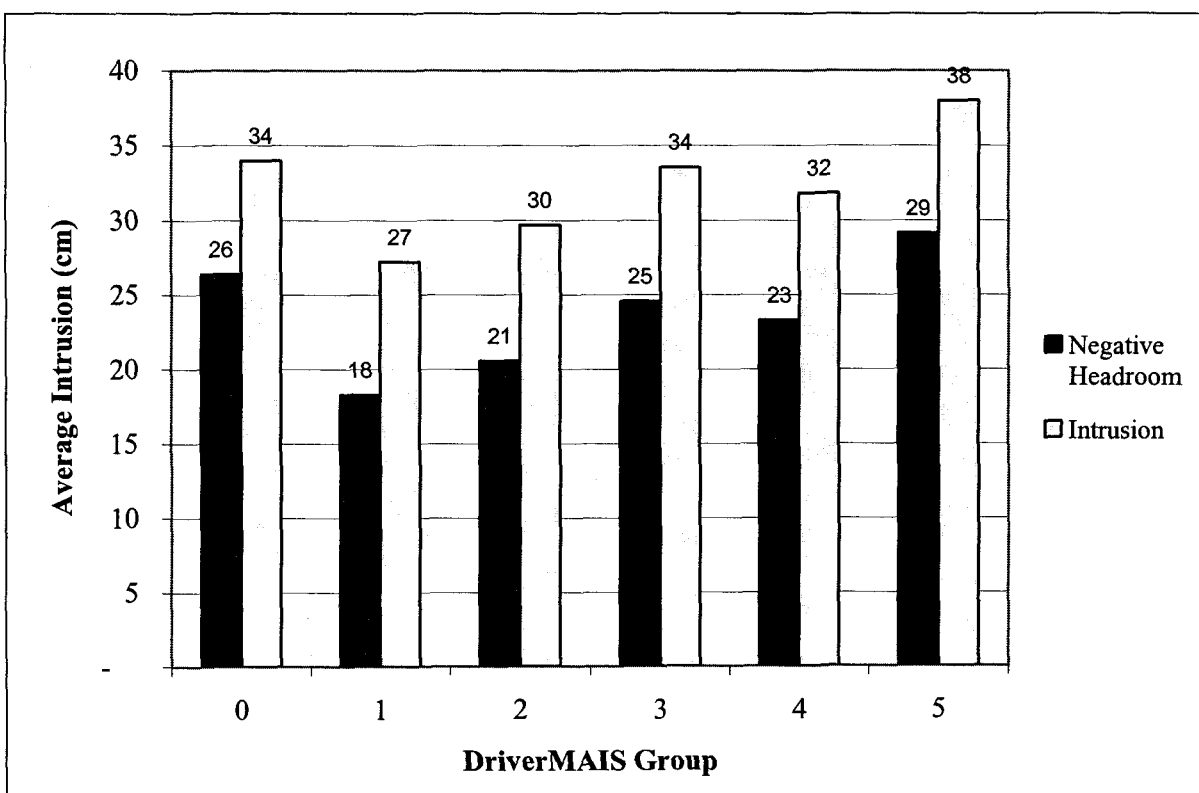
Figure 31: Intrusion and Negative Headroom vs. Driver MAIS Group

In order to analyze this contradiction, we first added mean headroom for each car group to the dataset and then subtracted the mean headroom from the total intrusion. This calculation is defined as negative headroom¹. The negative headroom allows us to see if the problem lies in the variable measured. The original dataset contained 273 cases. When we matched the 273 cases with the car groups, we eliminated 71 cases since they did not match with a car group, thereby leaving us with 202 cases. Figure 31 shows both intrusion and negative headroom for each MAIS group.

The above result shows that even when redefining the variable from intrusion to negative headroom there is still no change in the conclusion that higher MAIS injury levels do not correlate with more intrusion. This result led us to look at the photographs from all 202 remaining cases in the dataset to determine if there was improper reporting on the amount of total intrusion. There were 6 cases removed from the dataset due to improper reporting of intrusion levels, leaving 196 cases available for the analysis. This was based on the engineering review regarding intrusion levels from the data set photographs.

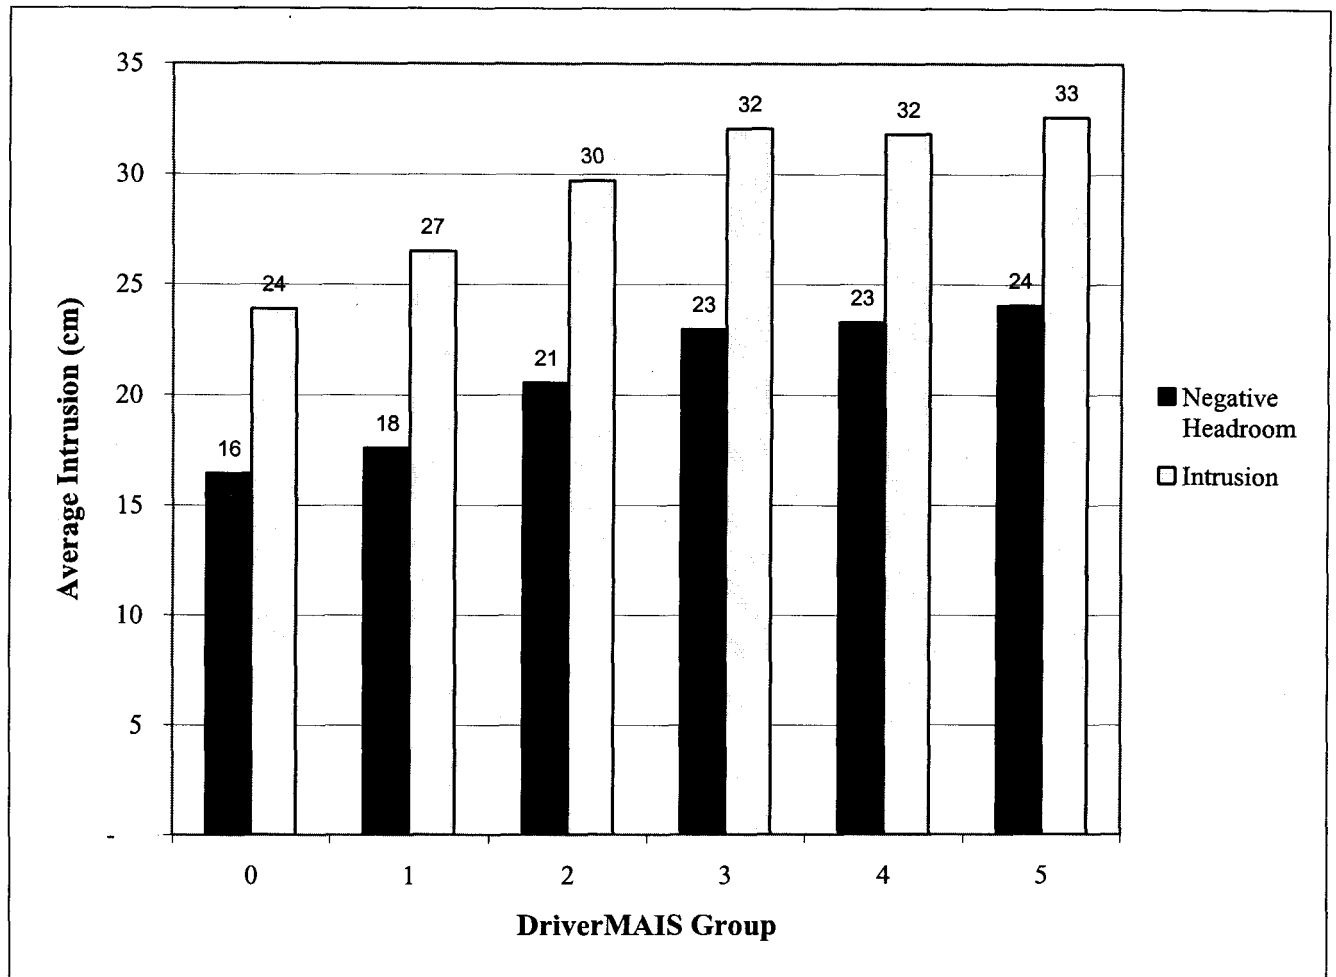
Figure 32: Intrusion and Negative Headroom vs. Driver MAIS Group

Once we eliminated cases with improper reporting on intrusion, we got more intuitive results. Figure 32 shows both intrusion and negative headroom for each MAIS group from the remaining data. As predicted, lower intrusion levels correspond to less injury. For instance, the average negative headroom for MAIS group 0 is 16 cm while the average negative headroom for MAIS group 5 is 24 cm.
