Re: 2004 - 2005 MY Toyota Highlander and Lexus RX330
2006 MY Toyota Highlander Hybrid and Lexus RX400h
Part 573, Defect Information Report

DEFECT INFORMATION REPORT

TECHNICAL INSTRUCTIONS
FOR
SPECIAL SERVICE CAMPAIGN 6LD
CENTER CONSOLE (FLOOR CARPET COVER)
RETAINING CLIP REPLACEMENT
FOR
2004 THROUGH 2005 MODEL YEAR RX 330 AND
EARLY 2006 MODEL YEAR RX 400h

2004 THROUGH 2005 HIGHLANDER AND
EARLY 2006 HIGHLANDER HV

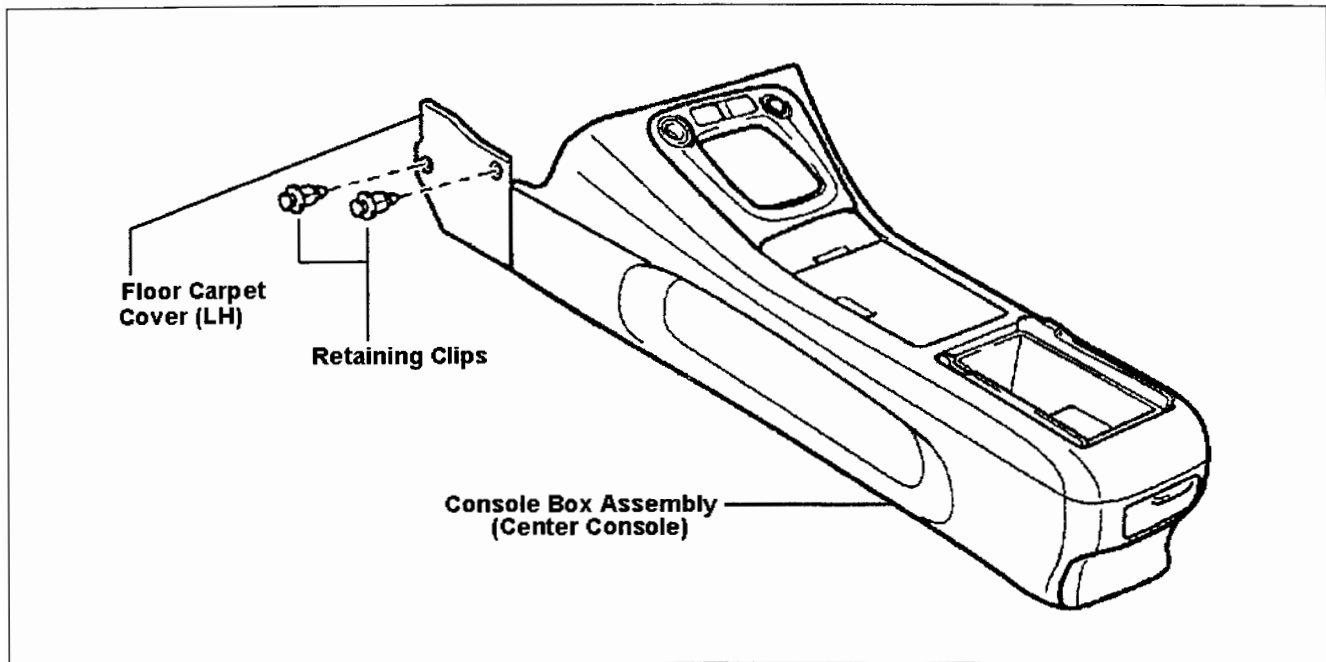
IV. COMPONENTS

In certain 2004 through 2005 model year Highlander and early 2006 model year Highlander Hybrid (HV) vehicles, due to improper installation, the two Retaining Clips for the driver's side forward Center Console (Floor Carpet Cover) can become loose. If both clips separate from the Floor Carpet Cover, the cover may lean toward the accelerator pedal, causing interference with the accelerator pedal rod.

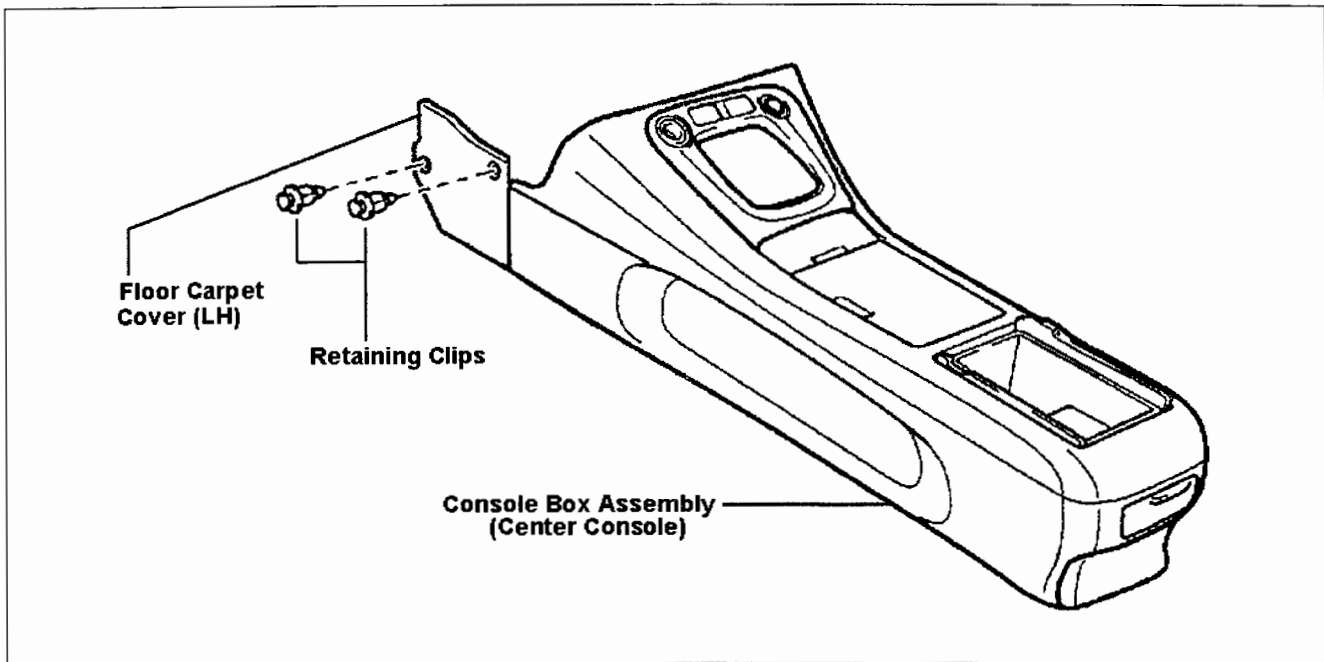
IV. COMPONENTS

In certain 2004 through 2005 model year Highlander and early 2006 model year Highlander Hybrid (HV) vehicles, due to improper installation, the two Retaining Clips for the driver's side forward Center Console (Floor Carpet Cover) can become loose. If both clips separate from the Floor Carpet Cover, the cover may lean toward the accelerator pedal, causing interference with the accelerator pedal rod.
